**Santos GLNG Project**  
**Lot 55 FTY1153**  
**Vegetation Management Zones Ecological Assessment**  
**Report**

February 2014

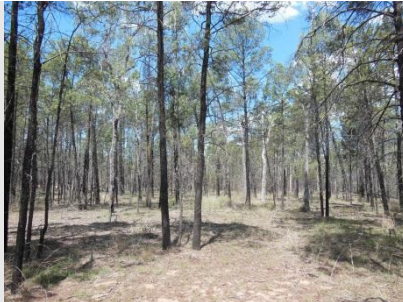
<p>Representative photo: Site Q 20</p> <p>Survey sites: Q1; Q2, Q3, Q9, Q10, Q18, Q19, Q20, VC3</p>

Community name	REs	Community characteristics	Fauna habitat value	Photo																																																																								
<p><i>Callitris glaucophylla</i> woodland to open-forest on coarse grained sediments on gently undulating to rolling hills <b>(<i>Callitris glaucophylla</i> woodland)</b></p>	11.10.9	<p>This community occurs across much of Lot 55, in well-connected patches adjacent to RE 11.10.11.</p> <p>This community comprises a woodland to open-forest community on gently undulating plains on deep sands, formed from medium to coarse-grained sediments, and is characterised by <i>Callitris glaucophylla</i> and <i>Eucalyptus populnea</i>. Other species such as <i>Eucalyptus melanophloia</i>, <i>Angophora leiocarpa</i> and <i>Eucalyptus chloroclada</i> are also present in the canopy.</p> <p>The vegetation cover is typically moderately dense (40 to 50 per cent), including the sub canopy layer. The shrub layer is typically moderately dense (20 to 40 per cent) and the ground layer is mostly sparse (20 to 30 per cent). Species composition in all strata consists of mainly native species.</p> <p>This community is in good condition across its distribution (VAST level 1-2) with low levels of weed infestation and moderate to severe edge effects due to clearing of remnant vegetation. Weeds occur predominately in the ground layer and included <i>Opuntia tomentosa</i>, <i>Opuntia stricta</i> and <i>Cenchrus ciliaris</i>. <i>Opuntia</i> spp. is the most commonly observed weed and was recorded at low densities at most sites within this vegetation community.</p>	<p>Survey sites: HA 1, HA 2, HA 3, HA 9, HA 10, HA 17, HA 18, HA 19 (n=8)</p>

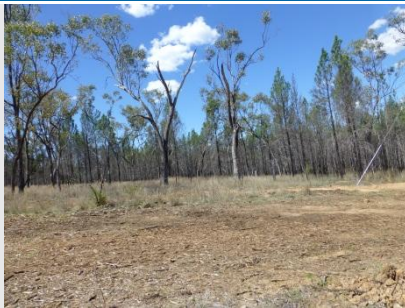
<p><b>^Abundance key: 0 = None, 1 = Rare, 2 = Rare to occasional, 3 = Occasional, 4 = Occasional to common, 5 = common, 6 = common to abundant, 7 = Abundant</b></p>	Trees with hollows		(Average per ha)	No. of trees containing hollows < 10 cm diameter		5.25 trees	Total number of hollows < 10 cm diameter		8 hollows	No. of trees containing hollows > 10 cm diameter		3.5 trees	Total number of hollows > 10 cm diameter		4.25 hollows	Hollow bearing logs		(Average per ha)	Number of logs with hollows > 10 cm diameter		2.25 logs	Total number of logs with hollows		4.5 logs	Fallen woody material		(Average per ha)	Total length of logs > 10 cm diameter		885 m	Total number of logs		277.5 logs	Abundance of other habitat characteristics			Characteristic	Abundance (0-7)^ (average per ha)		Decorticating bark	2.5		Course leaf litter (> 2 cm diameter)	2.25		Fine leaf litter (< 2 cm diameter)	2.1		Bare ground	4.5		Grass	4.5		Soil cracks	0		Stones (20–60 cm)	0		Boulders (61 cm – 2 m)	0		Large boulders (> 2 m)	0		Rock crevices	0		Exfoliating rock	0

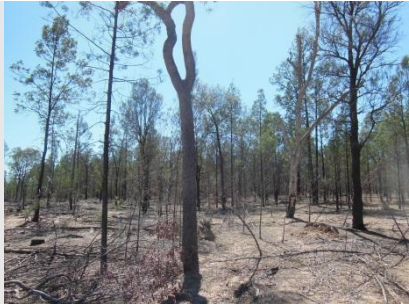
Community name	REs	Community characteristics	Fauna habitat value	Photo																																																				
<p>Non-remnant low regrowth woodland <b>(Non-remnant)</b></p>	<p>Non-remnant</p>	<p>This community was surveyed at six sites across Lot 55.</p> <p>This community ranges from low, moderately-dense regrowth <i>Eucalyptus populnea</i> and <i>Callitris glaucophylla</i>. All representative sites for this community occurred on flat to gently undulating land. Characteristic species include <i>Eucalyptus populnea</i>, <i>Eucalyptus melanophloia</i>, <i>Callitris glaucophylla</i>, <i>Allocasuarina luehmannii</i> and <i>Petalostigma pubescens</i>.</p> <p>The vegetation cover ranged from sparse to moderately-dense (10 to 50 per cent), including the sub canopy layer. The shrub layer was typically sparse (10 to 40 per cent) and the ground layer was mostly moderately-sparse (20 to 50 per cent). Species composition in all strata consisted of mainly native species.</p> <p>This community was in moderate condition across its distribution (VAST level 3) with low levels of weed infestation. Weeds occurred predominately in the ground layer at low densities and included <i>Opuntia tomentosa</i>, <i>Cenchrus ciliaris</i> and <i>Melinis repens</i>. <i>Opuntia tomentosa</i> was the most commonly observed weed and were recorded at low densities at most sites within this vegetation community.</p>

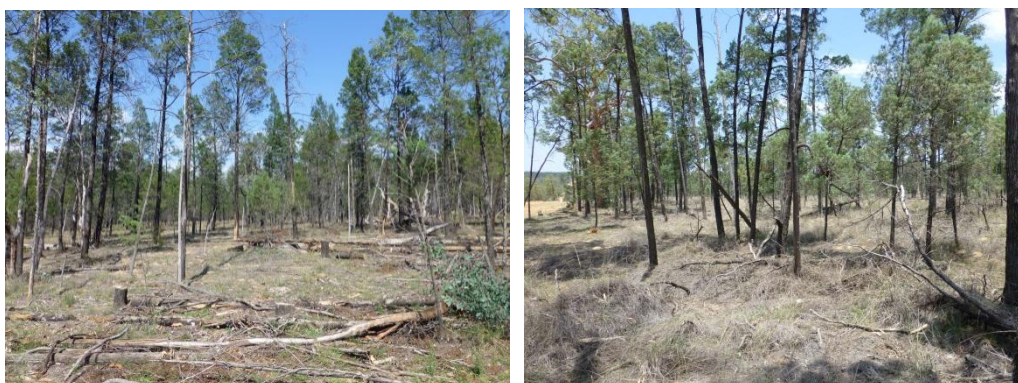
### Benchmark 1: *Callitris glaucophylla* open-forest

Representative ecosystem	Brigalow open-forest
Site vegetation description	<ul style="list-style-type: none"> <li><i>Callitris glaucophylla</i> woodland to open-forest often associated with <i>Eucalyptus melanophloia</i> in the tree canopy and a sparse ground layer</li> </ul>
Regional ecosystems sampled	11.10.9 (RPS <sup>1</sup> and GHD <sup>2</sup> )
Available DEHP benchmarks	None available
Site assessment information	<u>GHD (2013) sites<sup>2</sup></u> RE: 11.10.9. Site VC 3. Property: Lot 55 FTY1153 Location: 700633, 7144651 <u>RPS (2011) sites<sup>1</sup></u> RE: 11.10.9. Property: Springwater. Location: 148.955175, -25.762183
<sup>1</sup> CSG Gas Fields (Fairview, Roma and Arcadia Valley Project Areas) Remediation, Rehabilitation, Recovery and Monitoring Plan (RPS, 2011). <sup>2</sup> GHD ecological surveys undertaken in December 2013

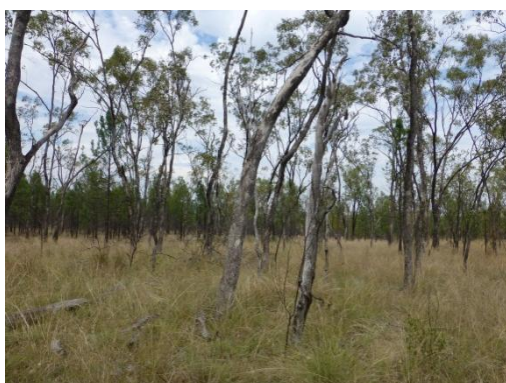
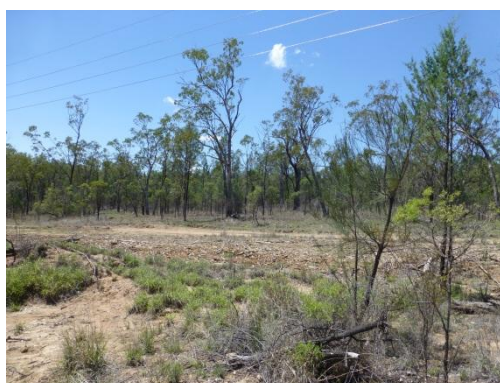
### Benchmark 2: Eucalypt woodland

Representative ecosystem	Brigalow open-forest
Site vegetation description	<ul style="list-style-type: none"> <li><i>Eucalyptus populnea</i>, <i>E. melanophloia</i> +/- <i>Callitris glaucophylla</i> woodland.</li> <li><i>Callitris glaucophylla</i> woodland to open-forest often associated with <i>Eucalyptus melanophloia</i> in the tree canopy and a sparse ground layer</li> </ul>
Regional ecosystems sampled	11.10.7a (RPS <sup>1</sup> ), 11.10.9 (GHD <sup>2</sup> ), 11.10.11 (RPS <sup>1</sup> and GHD <sup>2</sup> )
Available DEHP benchmarks	None available
Site assessment information	<p><u>GHD (2013) sites<sup>2</sup></u>  RE: 11.10.11. Site VC 5. Property: Lot 55 FTY1153  Location: 709850, 7147818  RE: 11.10.11. Site VC 4. Property: Lot 55 FTY1153  Location: 700126, 7142482</p> <p><u>RPS (2011) sites<sup>1</sup></u>  RE: 11.10.7a. Property: Fairview  Location: 148.970158, -25.641712  RE: 11.10.11. Property: Coxen Creek  Location: 149.114793, -26.367161</p>

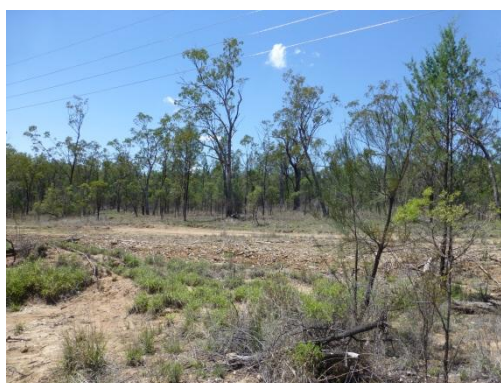
### Benchmark 3: Non-remnant

Representative ecosystem	Brigalow open-forest
Site vegetation description	<ul style="list-style-type: none"> <li>Cleared areas with very sparse mature eucalypts and <i>Callitris glaucophylla</i></li> <li>Low regrowth eucalypts and <i>Callitris glaucophylla</i> open-forest to woodland</li> </ul>
Regional ecosystems sampled	Non-remnant No equivalent sites were sampled by RPS <sup>1</sup>
Available DEHP benchmarks	Not applicable
Site assessment information	<u>GHD (2013) sites<sup>2</sup></u> RE: Non-remnant. Site VC 2. Property: Lot 55 FTY1153 Location: 699512, 7142652 RE: Non-remnant. Site VC 1. Property: Lot 55 FTY1153 Location: 699095, 7143732 <u>RPS (2011) Sites</u> No equivalent sites were sampled by RPS <sup>1</sup>
<sup>1</sup> CSG Gas Fields (Fairview, Roma and Arcadia Valley Project Areas) Remediation, Rehabilitation, Recovery and Monitoring Plan (RPS, 2011). <sup>2</sup> GHD ecological surveys undertaken in December 2013

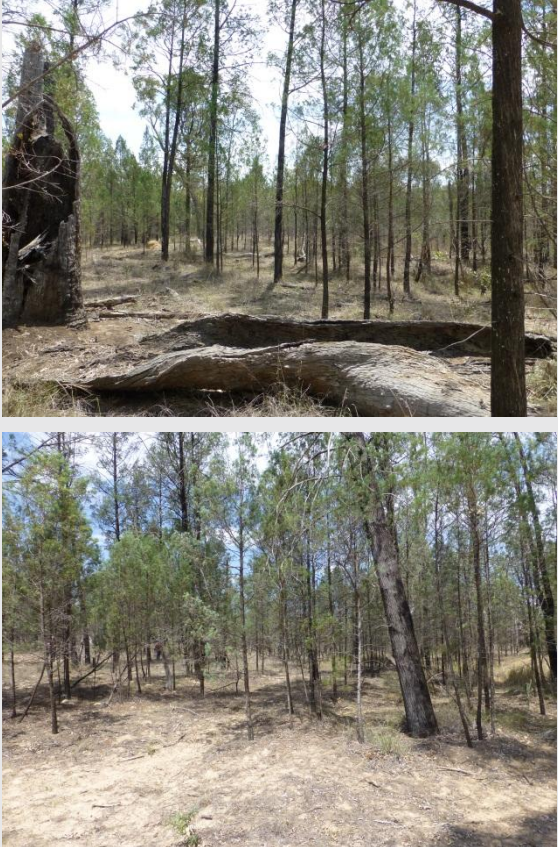
Polygon	Mapped RE	Observed RE	Community Description	Representative Photo
2	11.3.2	11.10.11	<p>This polygon is located in the north-eastern extent of Lot 55.</p> <p><b>Land zone:</b> Occurs on landforms derived from coarse-grained sediments with little or no deformation, including Jurassic chamositic ironstone, pelletal, or oolite cropping out as concretionary or oolitic limonite, consistent with land zones 9 or 10. Landforms are derived from the Westgrove Ironstone Member formation.</p> <p><b>Tree layers:</b> Field surveys found this area to contain a woodland polygon (10–14 m) dominated by <i>Eucalyptus populnea</i>. Other associated tree species observed includes <i>E. melanophloia</i> and <i>Eremophila mitchellii</i>.</p> <p><b>Shrub Layers:</b> The shrub layer was dominated by <i>Eremophila mitchellii</i>. Other shrub species included <i>Geijera parviflora</i>, <i>Callitris glaucophylla</i>, <i>Acacia leiocalyx</i> and <i>Grewia latifolia</i>.</p> <p><b>Ground Layer:</b> The groundcover consisted primarily of native grasses (sparse to moderately dense) including <i>Themeda triandra</i>, <i>Chrysopogon fallax</i>, <i>Sporobolus creber</i>, <i>Cymbopogon refractus</i>, <i>Enteropogon refractus</i> and <i>Aristida</i> sp.</p>

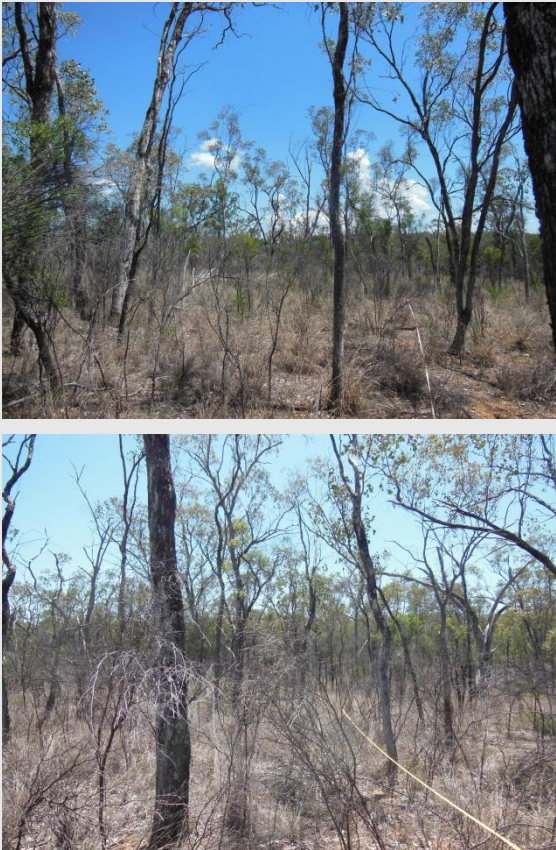
Polygon	Mapped RE	Observed RE	Community Description	Representative Photo
3	11.3.2	11.10.11	<p>This polygon is located in the north-eastern extent of Lot 55.</p> <p><b>Land zone:</b> Occurs on landforms derived from coarse-grained sediments with little or no deformation, including Jurassic chamositic ironstone, pelletal, or oolite cropping out as concretionary or oolitic limonite, consistent with land zones 9 or 10. Landforms are derived from the Westgrove Ironstone Member formation.</p> <p><b>Tree layers:</b> Field surveys found this area to contain a woodland polygon (10–14 m) dominated by <i>Eucalyptus populnea</i>. Other associated tree species observed includes <i>Brachychiton populneus</i>, <i>Callitris glaucophylla</i> and <i>Atalaya hemiglauca</i>.</p> <p><b>Shrub Layers:</b> The shrub layer was dominated by <i>Callitris glaucophylla</i> with <i>Eremophila mitchellii</i> occurring as a sub-dominant in this layer. Other shrub species included <i>Geijera parviflora</i>, <i>Dodonaea viscosa</i>, <i>Carissa ovata</i>, <i>Acacia decora</i>, <i>Acacia excelsa</i> subsp. <i>excelsa</i>.</p> <p><b>Ground Layer:</b> The groundcover consisted primarily of native grasses (sparse to moderately dense) including <i>Aristida caput-medusae</i>, <i>Cymbopogon refractus</i> and <i>Eragrostis setifolia</i>.</p>

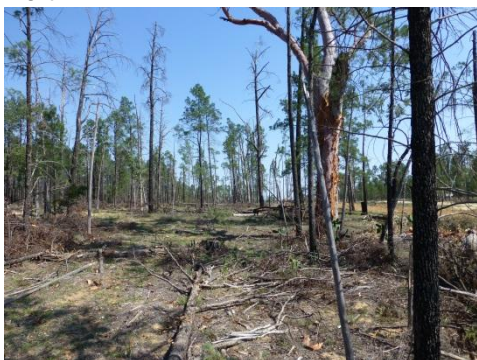
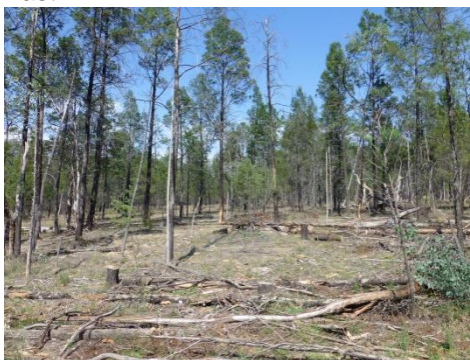
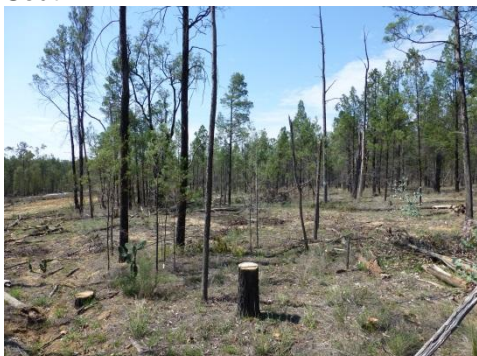
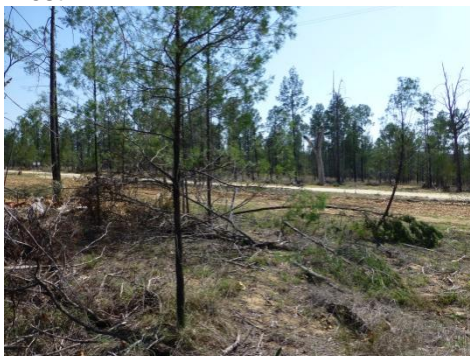
Site habitat assessment		
Site: HA 2	Date: 10/12/2013	Observers: LM
Photo nos: North: 456, East: 457, South: 458, West: 459		
RE type: 11.10.9	GPS Co-ords: 694503, 7143679	
<b>Habitat description:</b> Callitris dominated woodland to open forest, RoW 35		
<b>Trees with hollows (in 100 x 50 (0.5 ha area))</b>	<b>No. of trees containing hollows (tally)</b>	<b>Total number of hollows</b>
Hollow size < 10 cm diameter	3	3
Hollow size > 10 cm diameter	2	3
<b>Hollow bearing logs (in 100 x 50 (0.5 ha area)), hollows &gt;10 cm diameter</b>	<b>No. of logs containing hollows (tally)</b>	<b>Total number of hollows in logs</b>
	1	1
<b>Fallen woody material (in 50 x 10 (0.05 ha area))</b>	<b>Total length of logs &gt;10 cm diameter</b> Total: 24 m	<b>Total number of logs (tally)</b>
		4
<b>Other habitat characteristics (in 100 x 50 (0.5 ha area):</b>		
<b>Characteristic</b>	<b>Abundance (0-7)^</b>	<b>Notes</b>
Decorticating bark	4

Course leaf litter (>2cm diam)	1	
Fine leaf litter (<2cm diam)	0	
Bare ground	3	
Grass	6	
Soil cracks	0	
Stones (20-60 cm)	0	
Boulders (61 cm – 2 m)	0	
Large boulders (>2 m)	0	
Rock crevices	0	
Exfoliating rock	0	
^Abundance key: 0 = nil, 1 = Rare, 2 = Rare to occasional, 3 = Occasional, 4 = Occasional to common, 5 = common, 6 = common to abundant, 7 = Abundant		
<b>Other habitat features and notes</b> (e.g. potential threatened species): no threatened fauna recorded within vegetation management area hollow bearing trees are present in vegetation management zone, avoid clearing fauna habitat features potential habitat for golden tailed gecko, squatter pigeon

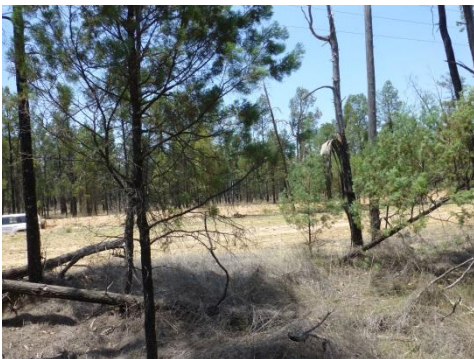
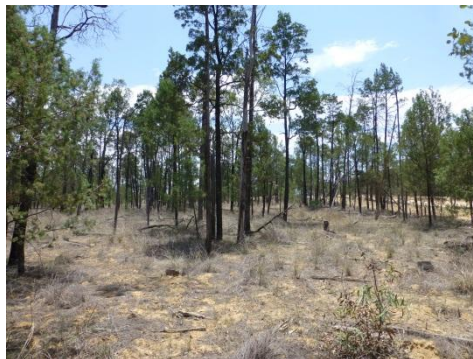
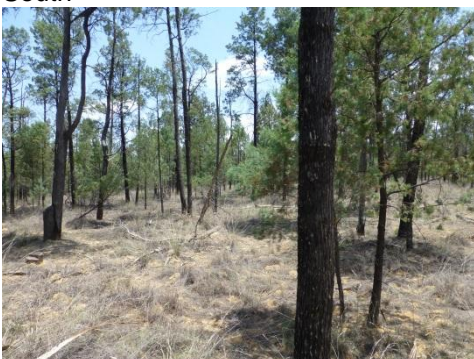
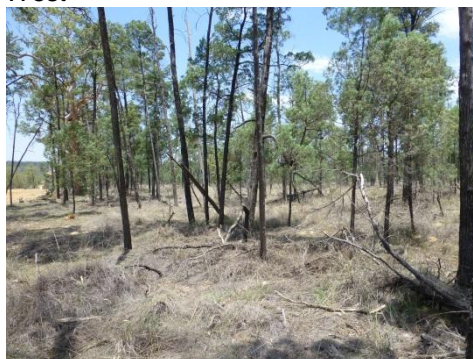
Site habitat assessment		
Site: HA 3	Date: 10/12/2013	Observers: LM
Photo nos: North: 460, East: 461, South: 462, West: 463		
RE type: 11.3.2/11.3.25	GPS Co-ords: 695023, 7143860	
<b>Habitat description:</b> Callitris dominated woodland to open forest, RoW 35		
<b>Trees with hollows (in 100 x 50 (0.5 ha area))</b>	<b>No. of trees containing hollows (tally)</b>	<b>Total number of hollows</b>
Hollow size < 10 cm diameter	1	3
Hollow size > 10 cm diameter	2	4
<b>Hollow bearing logs (in 100 x 50 (0.5 ha area)), hollows &gt;10 cm diameter</b>	<b>No. of logs containing hollows (tally)</b>	<b>Total number of hollows in logs</b>
	0	0
<b>Fallen woody material (in 50 x 10 (0.05 ha area))</b>	<b>Total length of logs &gt;10 cm diameter</b> Total: 55 m	<b>Total number of logs (tally)</b> 15
<b>Other habitat characteristics (in 100 x 50 (0.5 ha area):</b>		
<b>Characteristic</b>	<b>Abundance (0-7)^</b>	<b>Notes</b>

Decorticating bark	4	
Course leaf litter (>2cm diam)	1	
Fine leaf litter (<2cm diam)	0	
Bare ground	4	
Grass	5	
Soil cracks	0	
Stones (20-60 cm)	0	
Boulders (61 cm – 2 m)	0	
Large boulders (>2 m)	0	
Rock crevices	0	
Exfoliating rock	0	
^Abundance key: 0 = nil, 1 = Rare, 2 = Rare to occasional, 3 = Occasional, 4 = Occasional to common, 5 = common, 6 = common to abundant, 7 = Abundant		
<b>Other habitat features and notes (e.g. potential threatened species):</b> Potential habitat for golden tailed gecko, squatter pigeon

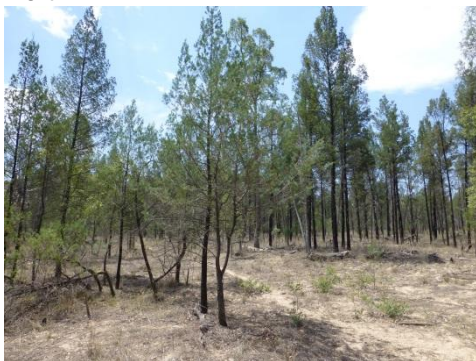
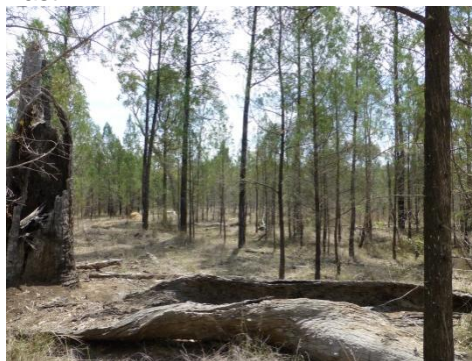
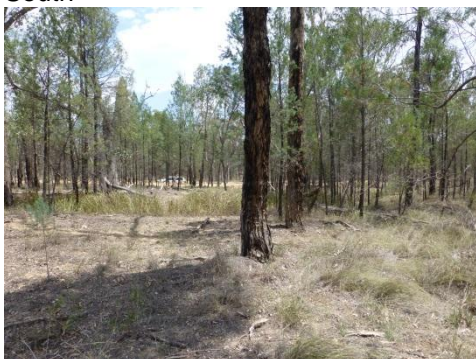
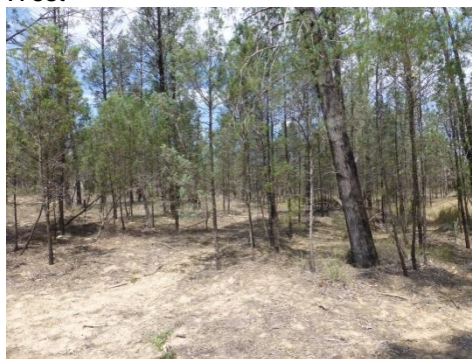
Site habitat assessment		
Site: HA 4	Date: 11/12/2013	Observers: LM
Photo nos: North: 466, East: 467, South: 468, West: 469		
RE type: 11.10.11	GPS Co-ords: 698462, 7144176	
<b>Habitat description:</b> <i>Eucalyptus populnea</i> woodland with dense callitris T2 understorey, sparse to mid-dense grass cover and scattered woody debris, RoW 42P		
<b>Trees with hollows (in 100 x 50 (0.5 ha area))</b>	<b>No. of trees containing hollows (tally)</b>	<b>Total number of hollows</b>
Hollow size < 10 cm diameter	5	7
Hollow size > 10 cm diameter	4	5
<b>Hollow bearing logs (in 100 x 50 (0.5 ha area)), hollows &gt;10 cm diameter</b>	<b>No. of logs containing hollows (tally)</b>	<b>Total number of hollows in logs</b>
	1	2
<b>Fallen woody material (in 50 x 10 (0.05 ha area))</b>	<b>Total length of logs &gt;10 cm diameter</b> Total: 60 m	<b>Total number of logs (tally)</b>
		18
<b>Other habitat characteristics (in 100 x 50 (0.5 ha area):</b>

<b>Characteristic</b>	<b>Abundance (0-7)^</b>	<b>Notes</b>
Decorticating bark	3	
Course leaf litter (>2cm diam)	1	
Fine leaf litter (<2cm diam)	4	
Bare ground	4	
Grass	3	
Soil cracks	0	
Stones (20-60 cm)	0	
Boulders (61 cm – 2 m)	0	
Large boulders (>2 m)	0	
Rock crevices	0	
Exfoliating rock	0	
^Abundance key: 0 = nil, 1 = Rare, 2 = Rare to occasional, 3 = Occasional, 4 = Occasional to common, 5 = common, 6 = common to abundant, 7 = Abundant		
<b>Other habitat features and notes</b> (e.g. potential threatened species): no threatened fauna recorded within vegetation management area avoid clearing fauna habitat features/potential breeding places within vegetation management area potential habitat for golden tailed gecko, squatter pigeon, brigalow scaly foot

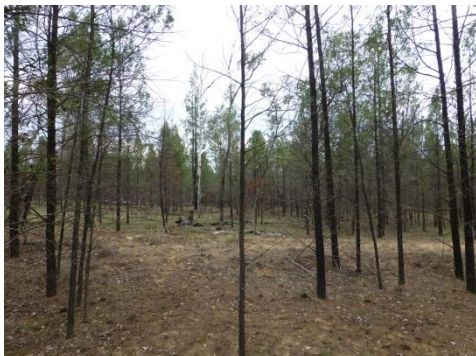
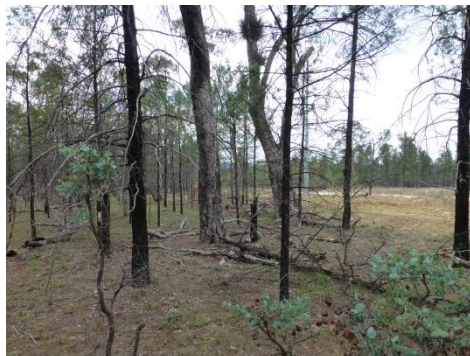
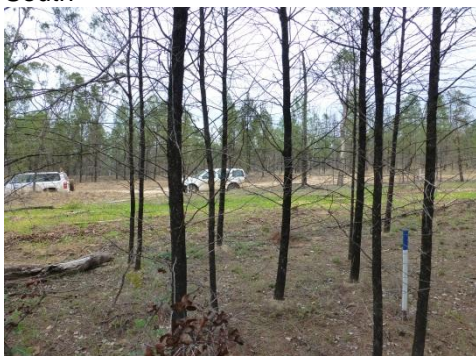
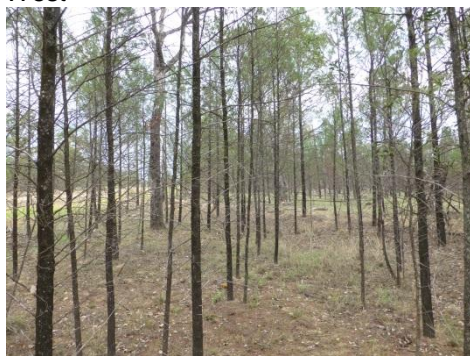
Site habitat assessment		
Site: HA 5	Date: 11/12/2013	Observers: LM
Photo nos: North: 470, East: 471, South: 472, West: 473		
RE type: regrowth and non-remnant	GPS Co-ords: 699092, 7143726	
<b>Habitat description:</b> <i>Eucalyptus populnea</i> woodland with mid-dense callitris T2 and shrub layer, mid-dense grassy groundcover and woody debris present, RoW 45		
<b>Trees with hollows (in 100 x 50 (0.5 ha area))</b>	<b>No. of trees containing hollows (tally)</b>	<b>Total number of hollows</b>
Hollow size < 10 cm diameter	4	6
Hollow size > 10 cm diameter	1	1
<b>Hollow bearing logs (in 100 x 50 (0.5 ha area)), hollows &gt;10 cm diameter</b>	<b>No. of logs containing hollows (tally)</b>	<b>Total number of hollows in logs</b>
	4	6
<b>Fallen woody material (in 50 x 10 (0.05 ha area))</b>	<b>Total length of logs &gt;10 cm diameter</b>	<b>Total number of logs (tally)</b>
	Total: 25 m	6
<b>Other habitat characteristics (in 100 x 50 (0.5 ha area):</b>

<b>Characteristic</b>	<b>Abundance (0-7)^</b>	<b>Notes</b>
Decorticated bark	2	
Course leaf litter (>2cm diam)	1	
Fine leaf litter (<2cm diam)	3	
Bare ground	4	
Grass	4	
Soil cracks	0	
Stones (20-60 cm)	2	
Boulders (61 cm – 2 m)	0	
Large boulders (>2 m)	2	
Rock crevices	0	
Exfoliating rock	0	
^Abundance key: 0 = nil, 1 = Rare, 2 = Rare to occasional, 3 = Occasional, 4 = Occasional to common, 5 = common, 6 = common to abundant, 7 = Abundant		
<b>Other habitat features and notes</b> (e.g. potential threatened species): No threatened fauna recorded within vegetation management area, some clearing within vegetation management area has already occurred from adjacent powerline RoW. Avoid clearing fauna habitat features/potential breeding places within vegetation management area Potential habitat for golden tailed gecko

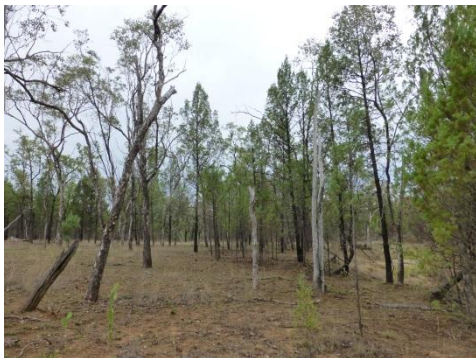
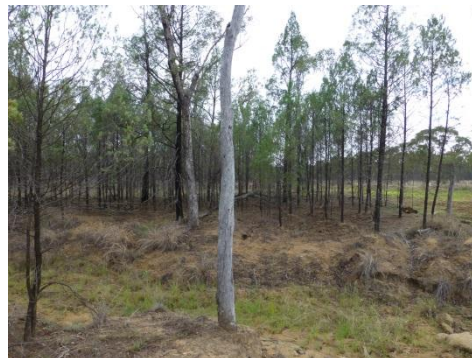
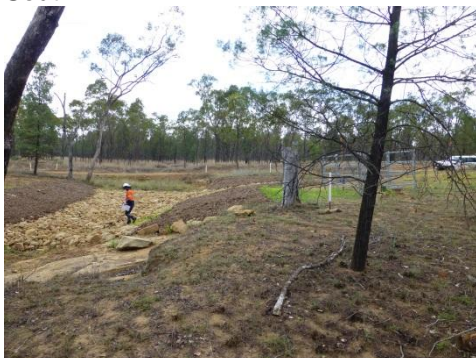
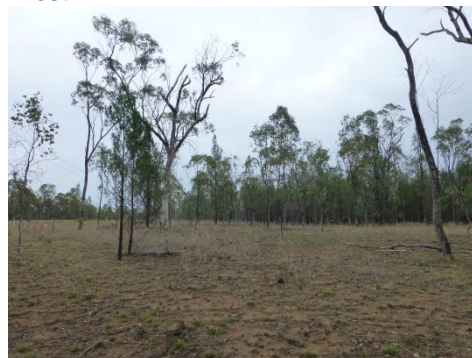
Site habitat assessment		
Site: HA 6	Date: 11/12/2013	Observers: LM
Photo nos: North: 480, East: 481, South: 482, West: 483		
RE type: 11.10.11	GPS Co-ords: 700248, 7143177	
<b>Habitat description:</b> <i>Eucalyptus populnea</i> woodland with mid-dense callitris shrub layer, dense grassy groundcover and scattered woody debris, RoW 49		
<b>Trees with hollows (in 100 x 50 (0.5 ha area))</b>	<b>No. of trees containing hollows (tally)</b>	<b>Total number of hollows</b>
Hollow size < 10 cm diameter	0	0
Hollow size > 10 cm diameter	1	1
<b>Hollow bearing logs (in 100 x 50 (0.5 ha area)), hollows &gt;10 cm diameter</b>	<b>No. of logs containing hollows (tally)</b>	<b>Total number of hollows in logs</b>
	2	4
<b>Fallen woody material (in 50 x 10 (0.05 ha area))</b>	<b>Total length of logs &gt;10 cm diameter</b> Total: 27 m	<b>Total number of logs (tally)</b>
		12
<b>Other habitat characteristics (in 100 x 50 (0.5 ha area):</b>

<b>Characteristic</b>	<b>Abundance (0-7)^</b>	<b>Notes</b>
Decorticating bark	2	
Course leaf litter (>2cm diam)	2	
Fine leaf litter (<2cm diam)	1	
Bare ground	3	
Grass	6	
Soil cracks	0	
Stones (20-60 cm)	0	
Boulders (61 cm – 2 m)	0	
Large boulders (>2 m)	0	
Rock crevices	0	
Exfoliating rock	0	
^Abundance key: 0 = nil, 1 = Rare, 2 = Rare to occasional, 3 = Occasional, 4 = Occasional to common, 5 = common, 6 = common to abundant, 7 = Abundant		
<b>Other habitat features and notes (e.g. potential threatened species):</b> no threatened fauna recorded within vegetation management area avoid clearing fauna habitat features/potential breeding places within vegetation management area potential habitat for golden tailed gecko, squatter pigeon

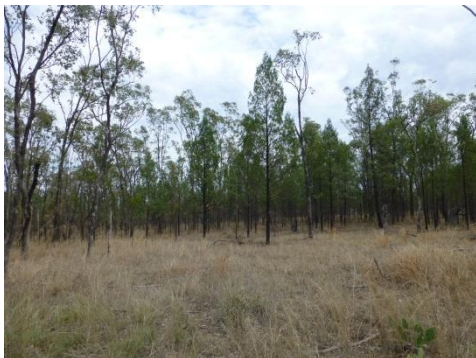
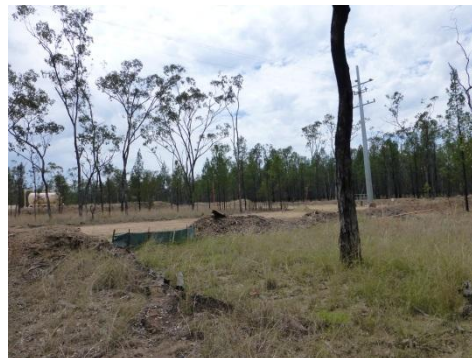
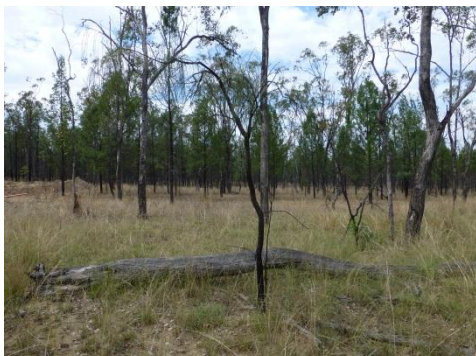
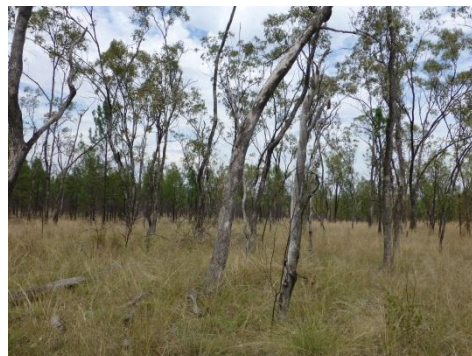
Site habitat assessment		
Site: HA 7	Date: 11/12/2013	Observers: LM
Photo nos: North: 484, East: 485, South: 486, West: 487		
RE type: non-remnant	GPS Co-ords: 699464, 7142611	
<b>Habitat description:</b> Scattered mature and juvenile eucalypts, very open woodland, sparse to mid dense shrubs including callitirs and casuarinas, RoW 45P		
<b>Trees with hollows (in 100 x 50 (0.5 ha area))</b>	<b>No. of trees containing hollows (tally)</b>	<b>Total number of hollows</b>
Hollow size < 10 cm diameter	0	0
Hollow size > 10 cm diameter	0	0
<b>Hollow bearing logs (in 100 x 50 (0.5 ha area)), hollows &gt;10 cm diameter</b>	<b>No. of logs containing hollows (tally)</b>	<b>Total number of hollows in logs</b>
	0	0
<b>Fallen woody material (in 50 x 10 (0.05 ha area))</b>	<b>Total length of logs &gt;10 cm diameter</b> Total: 5 m	<b>Total number of logs (tally)</b>
		2
<b>Other habitat characteristics (in 100 x 50 (0.5 ha area):</b>

<b>Characteristic</b>	<b>Abundance (0-7)^</b>	<b>Notes</b>
Decorticating bark	2	
Course leaf litter (>2cm diam)	0	
Fine leaf litter (<2cm diam)	0	
Bare ground	5	
Grass	4	
Soil cracks	0	
Stones (20-60 cm)	0	
Boulders (61 cm – 2 m)	0	
Large boulders (>2 m)	0	
Rock crevices	0	
Exfoliating rock	0	
^Abundance key: 0 = nil, 1 = Rare, 2 = Rare to occasional, 3 = Occasional, 4 = Occasional to common, 5 = common, 6 = common to abundant, 7 = Abundant		
<b>Other habitat features and notes (e.g. potential threatened species):</b> no threatened fauna recorded within vegetation management area avoid clearing fauna habitat features/potential breeding places within vegetation management area potential habitat for square tailed kite, squatter pigeon

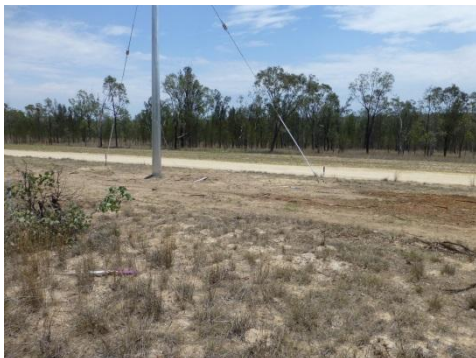
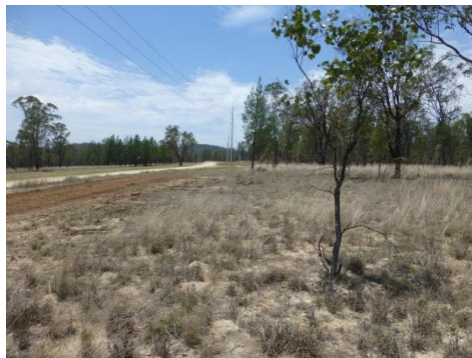
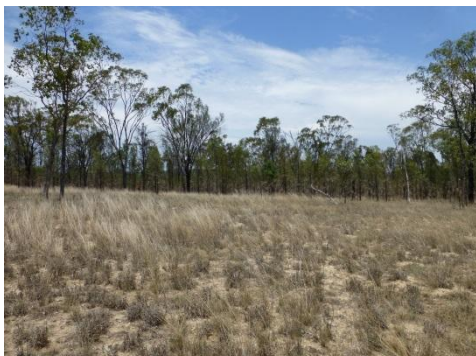
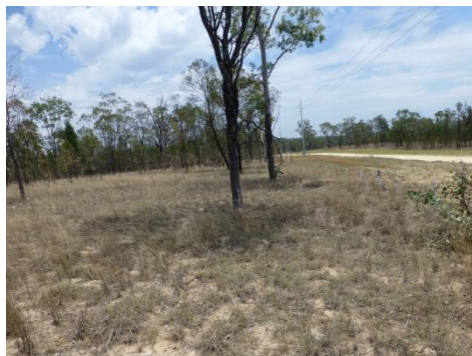
Site habitat assessment		
Site: HA 8	Date: 11/12/2013	Observers: LM
Photo nos: North: 488, East: 489, South: 490, West: 491		
RE type: regrowth	GPS Co-ords: 699745, 7142460	
<b>Habitat description:</b> Dense stand of young callitris small trees with emergent eucalypts, grassy understorey, RoW 47		
<b>Trees with hollows (in 100 x 50 (0.5 ha area))</b>	<b>No. of trees containing hollows (tally)</b>	<b>Total number of hollows</b>
Hollow size < 10 cm diameter	0	0
Hollow size > 10 cm diameter	1	1
<b>Hollow bearing logs (in 100 x 50 (0.5 ha area)), hollows &gt;10 cm diameter</b>	<b>No. of logs containing hollows (tally)</b>	<b>Total number of hollows in logs</b>
	1	2
<b>Fallen woody material (in 50 x 10 (0.05 ha area))</b>	<b>Total length of logs &gt;10 cm diameter</b> Total: 22 m	<b>Total number of logs (tally)</b>
		5
<b>Other habitat characteristics (in 100 x 50 (0.5 ha area):</b>		
<b>Characteristic</b>	<b>Abundance (0-7)^</b>	<b>Notes</b>

Decorticating bark	2	
Course leaf litter (>2cm diam)	3	
Fine leaf litter (<2cm diam)	3	
Bare ground	3	
Grass	5	
Soil cracks	0	
Stones (20-60 cm)	0	
Boulders (61 cm – 2 m)	0	
Large boulders (>2 m)	0	
Rock crevices	0	
Exfoliating rock	0	
^Abundance key: 0 = nil, 1 = Rare, 2 = Rare to occasional, 3 = Occasional, 4 = Occasional to common, 5 = common, 6 = common to abundant, 7 = Abundant		
<b>Other habitat features and notes (e.g. potential threatened species):</b> no threatened fauna recorded within vegetation management area avoid clearing fauna habitat features/potential breeding places within vegetation management area potential habitat for square tailed kite, squatter pigeon

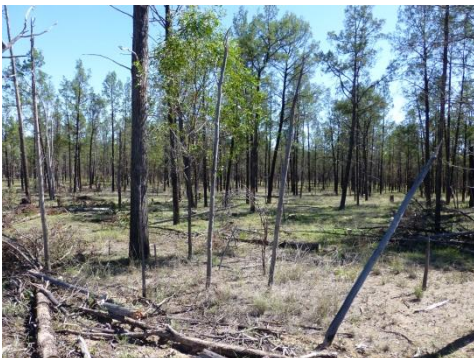
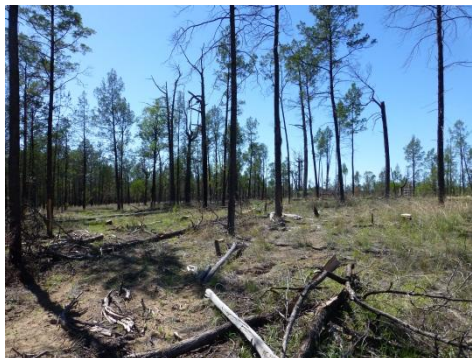
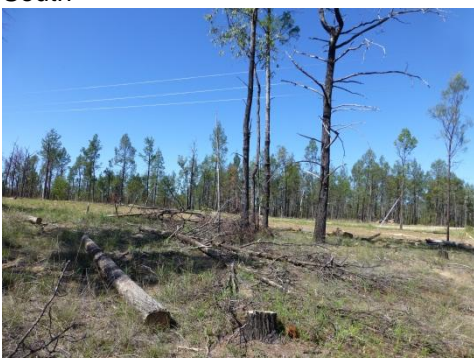
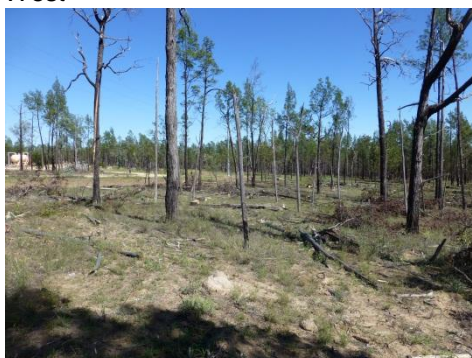
Site habitat assessment		
Site: HA 9	Date: 13/12/2013	Observers: LM
Photo nos: North: 492, East: 493, South: 494, West: 495		
RE type: 11.10.9	GPS Co-ords: 700443, 7145190	
<b>Habitat description:</b> Callitris dominated open forest with a grassy understorey, RoW 43		
<b>Trees with hollows (in 100 x 50 (0.5 ha area))</b>	<b>No. of trees containing hollows (tally)</b>	<b>Total number of hollows</b>
Hollow size < 10 cm diameter	0	0
Hollow size > 10 cm diameter	0	0
<b>Hollow bearing logs (in 100 x 50 (0.5 ha area)), hollows &gt;10 cm diameter</b>	<b>No. of logs containing hollows (tally)</b>	<b>Total number of hollows in logs</b>
	0	0
<b>Fallen woody material (in 50 x 10 (0.05 ha area))</b>	<b>Total length of logs &gt;10 cm diameter</b> Total: 63 m	<b>Total number of logs (tally)</b> 26
<b>Other habitat characteristics (in 100 x 50 (0.5 ha area):</b>		
<b>Characteristic</b>	<b>Abundance (0-7)^</b>	<b>Notes</b>

Decorticating bark	3	
Course leaf litter (>2cm diam)	0	
Fine leaf litter (<2cm diam)	0	
Bare ground	5	
Grass	5	
Soil cracks	0	
Stones (20-60 cm)	0	
Boulders (61 cm – 2 m)	0	
Large boulders (>2 m)	0	
Rock crevices	0	
Exfoliating rock	0	
^Abundance key: 0 = nil, 1 = Rare, 2 = Rare to occasional, 3 = Occasional, 4 = Occasional to common, 5 = common, 6 = common to abundant, 7 = Abundant		
<b>Other habitat features and notes (e.g. potential threatened species):</b> no threatened fauna recorded within vegetation management area avoid clearing fauna habitat features/potential breeding places within vegetation management area vegetation management area is mostly cleared from previous forestry clearing

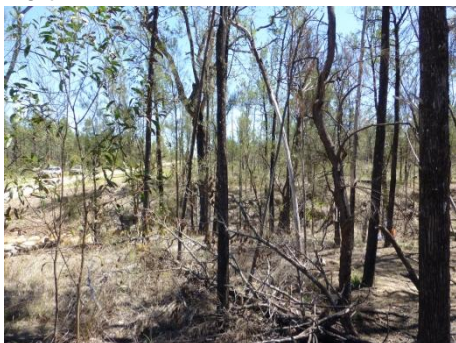
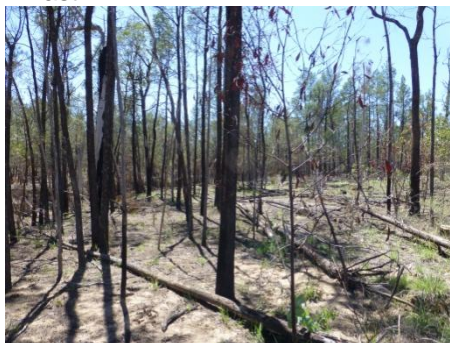
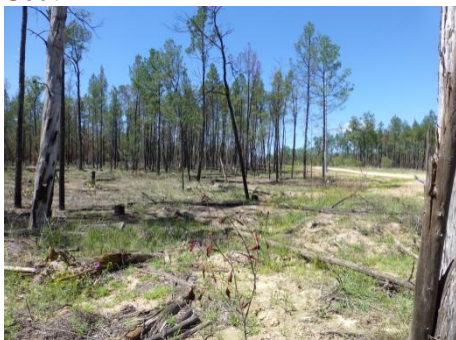
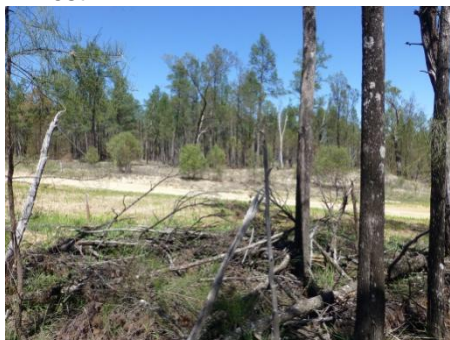
Site habitat assessment		
Site: HA 10	Date: 13/12/2013	Observers: LM
Photo nos: North: 501, East: 502, South: 503, West: 504		
RE type: 11.10.9	GPS Co-ords: 700528, 7144640	
<b>Habitat description:</b> Callitris dominated open forest with a grassy understorey, RoW 45		
<b>Trees with hollows (in 100 x 50 (0.5 ha area))</b>	<b>No. of trees containing hollows (tally)</b>	<b>Total number of hollows</b>
Hollow size < 10 cm diameter	2	2
Hollow size > 10 cm diameter	0	0
<b>Hollow bearing logs (in 100 x 50 (0.5 ha area)), hollows &gt;10 cm diameter</b>	<b>No. of logs containing hollows (tally)</b>	<b>Total number of hollows in logs</b>
	0	0
<b>Fallen woody material (in 50 x 10 (0.05 ha area))</b>	<b>Total length of logs &gt;10 cm diameter</b> Total: 110 m	<b>Total number of logs (tally)</b> 26
<b>Other habitat characteristics (in 100 x 50 (0.5 ha area):</b>		
<b>Characteristic</b>	<b>Abundance (0-7)^</b>	<b>Notes</b>

Decorticating bark	3	
Course leaf litter (>2cm diam)	1	
Fine leaf litter (<2cm diam)	1	
Bare ground	5	
Grass	4	
Soil cracks	0	
Stones (20-60 cm)	0	
Boulders (61 cm – 2 m)	1	
Large boulders (>2 m)	0	
Rock crevices	0	
Exfoliating rock	0	
^Abundance key: 0 = nil, 1 = Rare, 2 = Rare to occasional, 3 = Occasional, 4 = Occasional to common, 5 = common, 6 = common to abundant, 7 = Abundant		
<b>Other habitat features and notes (e.g. potential threatened species):</b> no threatened fauna recorded within vegetation management area avoid clearing fauna habitat features/potential breeding places within vegetation management area potential habitat for golden tailed gecko, squatter pigeon vegetation management area is partially cleared from logging and adjacent powerline RoW

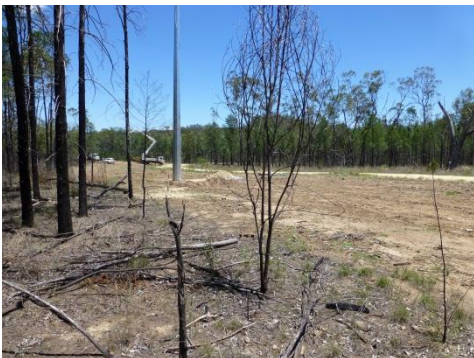
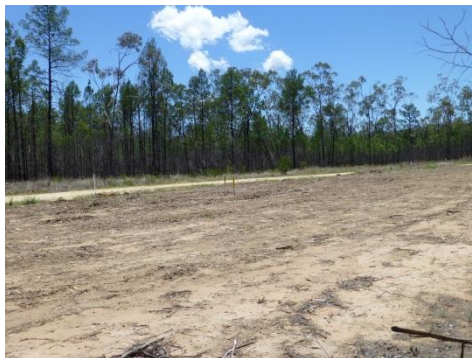
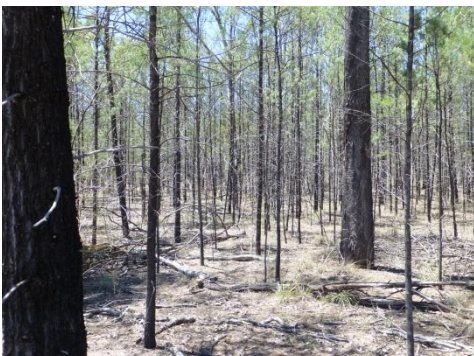
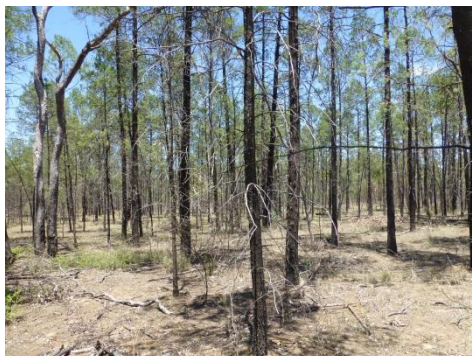
Site habitat assessment		
Site: HA 11	Date: 13/12/2013	Observers: LM
Photo nos: North: 505, East: 506, South: 507, West: 508		
RE type: 11.10.11	GPS Co-ords: 701137, 7142537	
<b>Habitat description:</b> <i>Eucalyptus populnea</i> open woodland with dense callitiris understorey, RoW 48		
<b>Trees with hollows (in 100 x 50 (0.5 ha area))</b>	<b>No. of trees containing hollows (tally)</b>	<b>Total number of hollows</b>
Hollow size < 10 cm diameter	4	4
Hollow size > 10 cm diameter	0	0
<b>Hollow bearing logs (in 100 x 50 (0.5 ha area)), hollows &gt;10 cm diameter</b>	<b>No. of logs containing hollows (tally)</b>	<b>Total number of hollows in logs</b>
	0	0
<b>Fallen woody material (in 50 x 10 (0.05 ha area))</b>	<b>Total length of logs &gt;10 cm diameter</b> Total: 42 m	<b>Total number of logs (tally)</b> 13
<b>Other habitat characteristics (in 100 x 50 (0.5 ha area):</b>		
<b>Characteristic</b>	<b>Abundance (0-7)^</b>	<b>Notes</b>

Decorticating bark	2	
Course leaf litter (>2cm diam)	2	
Fine leaf litter (<2cm diam)	2	
Bare ground	5	
Grass	3	
Soil cracks	0	
Stones (20-60 cm)	0	
Boulders (61 cm – 2 m)	0	
Large boulders (>2 m)	0	
Rock crevices	0	
Exfoliating rock	0	
^Abundance key: 0 = nil, 1 = Rare, 2 = Rare to occasional, 3 = Occasional, 4 = Occasional to common, 5 = common, 6 = common to abundant, 7 = Abundant		
<b>Other habitat features and notes (e.g. potential threatened species):</b> no threatened fauna recorded within vegetation management area avoid clearing fauna habitat features/potential breeding places within vegetation management area potential habitat for golden tailed gecko, squatter pigeon

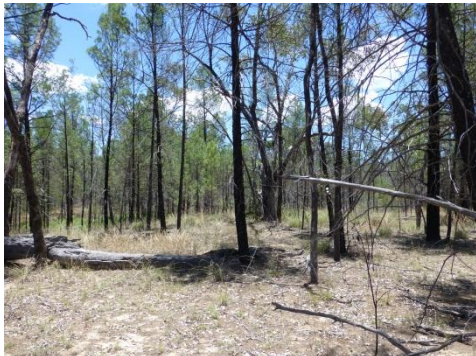
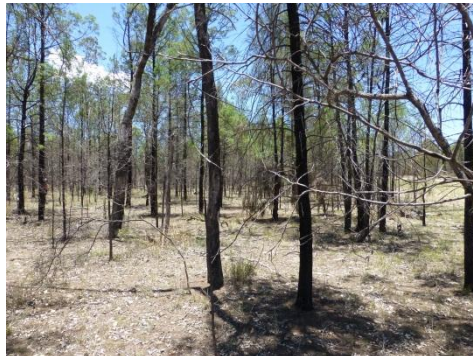
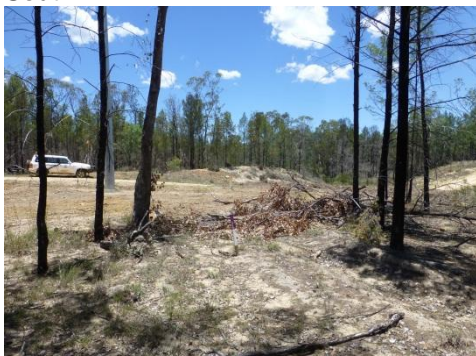
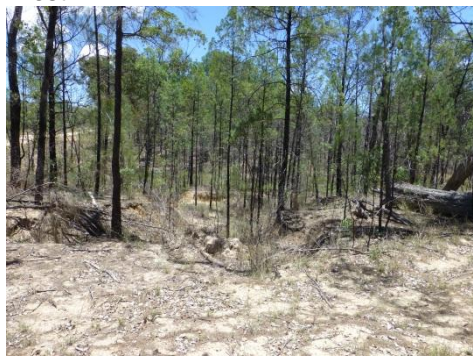
Site habitat assessment		
Site: HA 12	Date: 13/12/2013	Observers: LM
Photo nos: North: 513, East: 514, South: 515, West: 516		
RE type: 11.10.11	GPS Co-ords: 700034, 7142426	
<b>Habitat description:</b> <i>Eucalyptus populnea</i> open woodland with dense callitiris and casuarina understorey, RoW 48		
<b>Trees with hollows (in 100 x 50 (0.5 ha area))</b>	<b>No. of trees containing hollows (tally)</b>	<b>Total number of hollows</b>
Hollow size < 10 cm diameter	0	0
Hollow size > 10 cm diameter	1	1
<b>Hollow bearing logs (in 100 x 50 (0.5 ha area)), hollows &gt;10 cm diameter</b>	<b>No. of logs containing hollows (tally)</b>	<b>Total number of hollows in logs</b>
	3	5
<b>Fallen woody material (in 50 x 10 (0.05 ha area))</b>	<b>Total length of logs &gt;10 cm diameter</b>	<b>Total number of logs (tally)</b>
	Total: 53 m	11
<b>Other habitat characteristics (in 100 x 50 (0.5 ha area):</b>		
<b>Characteristic</b>	<b>Abundance (0-7)^</b>	<b>Notes</b>

Decorticating bark	3	
Course leaf litter (>2cm diam)	3	
Fine leaf litter (<2cm diam)	3	
Bare ground	6	
Grass	4	
Soil cracks	0	
Stones (20-60 cm)	0	
Boulders (61 cm – 2 m)	0	
Large boulders (>2 m)	0	
Rock crevices	0	
Exfoliating rock	0	
^Abundance key: 0 = nil, 1 = Rare, 2 = Rare to occasional, 3 = Occasional, 4 = Occasional to common, 5 = common, 6 = common to abundant, 7 = Abundant		
<b>Other habitat features and notes (e.g. potential threatened species):</b> Avoid clearing this vegetation management area if possible, particularly as there are fauna habitat features/breeding places, watercourses, type A restricted species and potential habitat for threatened species within the area No threatened fauna recorded within vegetation management area, potential habitat for golden tailed gecko, squatter pigeon, brigalow scaly foot, koala. Avoid clearing fauna habitat features/potential breeding places within vegetation management area

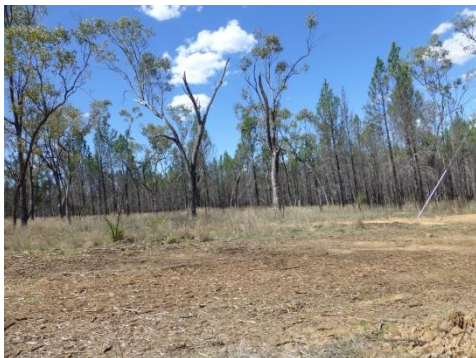
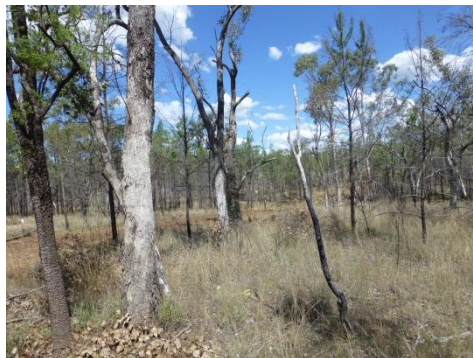
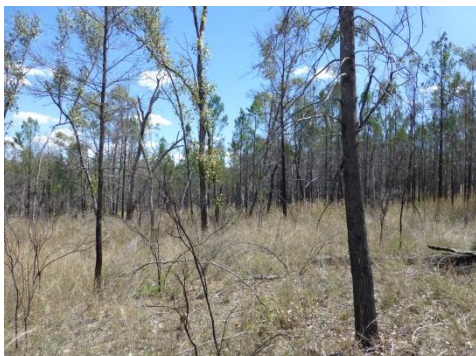
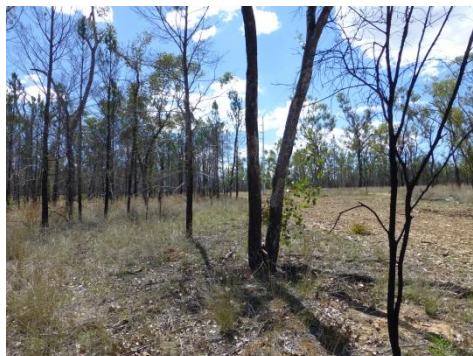
Site habitat assessment		
Site: HA 13	Date: 13/12/2013	Observers: LM
Photo nos: North: 523, East: 524, South: 525, West: 526		
RE type: 11.10.11/11.10.7a	GPS Co-ords: 708208, 7143396	
<b>Habitat description:</b> <i>Eucalyptus populnea</i> woodland with dense to mid-dense mixed shrubby understorey , RoW 4BP		
<b>Trees with hollows (in 100 x 50 (0.5 ha area))</b>	<b>No. of trees containing hollows (tally)</b>	<b>Total number of hollows</b>
Hollow size < 10 cm diameter	2	4
Hollow size > 10 cm diameter	1	1
<b>Hollow bearing logs (in 100 x 50 (0.5 ha area)), hollows &gt;10 cm diameter</b>	<b>No. of logs containing hollows (tally)</b>	<b>Total number of hollows in logs</b>
	0	0
<b>Fallen woody material (in 50 x 10 (0.05 ha area))</b>	<b>Total length of logs &gt;10 cm diameter</b> Total: 25 m	<b>Total number of logs (tally)</b>
		8
<b>Other habitat characteristics (in 100 x 50 (0.5 ha area):</b>		
<b>Characteristic</b>	<b>Abundance (0-7)^</b>	<b>Notes</b>

Decorticating bark	2	
Course leaf litter (>2cm diam)	3	
Fine leaf litter (<2cm diam)	1	
Bare ground	4	
Grass	6	
Soil cracks	0	
Stones (20-60 cm)	0	
Boulders (61 cm – 2 m)	0	
Large boulders (>2 m)	0	
Rock crevices	0	
Exfoliating rock	0	
^Abundance key: 0 = nil, 1 = Rare, 2 = Rare to occasional, 3 = Occasional, 4 = Occasional to common, 5 = common, 6 = common to abundant, 7 = Abundant		
<b>Other habitat features and notes (e.g. potential threatened species):</b> no threatened fauna recorded within vegetation management area avoid clearing fauna habitat features/potential breeding places within vegetation management area potential habitat for squatter pigeon, powerful owl, koala

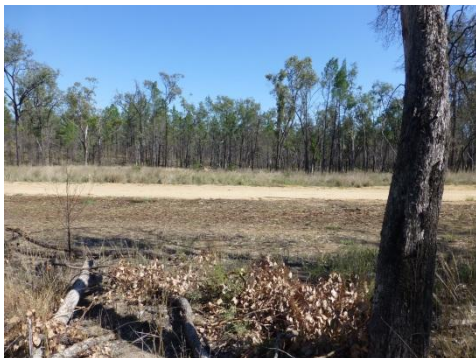
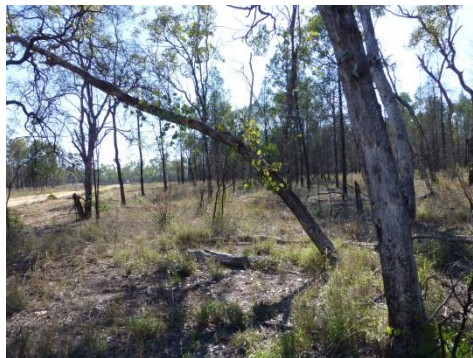
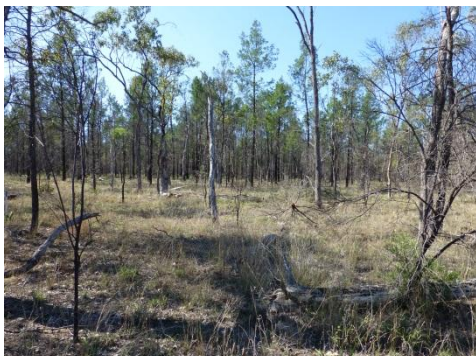
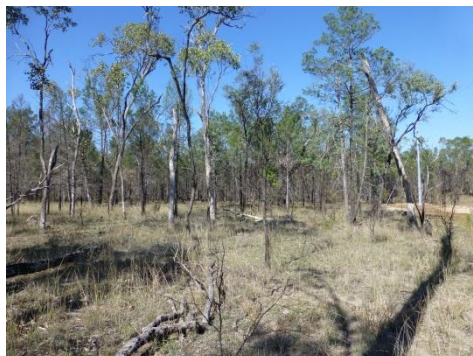
Site habitat assessment		
Site: HA 14	Date: 14/12/2013	Observers: LM
Photo nos: North: 531, East: 532, South: 533, West: 534		
RE type: 11.10.11/11.10.7a	GPS Co-ords: 706846, 7143341	
<b>Habitat description:</b> <i>Eucalyptus populnea</i> woodland with mixed shrublayer, RoW 4BP		
<b>Trees with hollows (in 100 x 50 (0.5 ha area))</b>	<b>No. of trees containing hollows (tally)</b>	<b>Total number of hollows</b>
Hollow size < 10 cm diameter	5	7
Hollow size > 10 cm diameter	3	3
<b>Hollow bearing logs (in 100 x 50 (0.5 ha area)), hollows &gt;10 cm diameter</b>	<b>No. of logs containing hollows (tally)</b>	<b>Total number of hollows in logs</b>
	3	7
<b>Fallen woody material (in 50 x 10 (0.05 ha area))</b>	<b>Total length of logs &gt;10 cm diameter</b> Total: 44 m	<b>Total number of logs (tally)</b> 17
<b>Other habitat characteristics (in 100 x 50 (0.5 ha area):</b>		
<b>Characteristic</b>	<b>Abundance (0-7)^</b>	<b>Notes</b>

Decorticating bark	2	
Course leaf litter (>2cm diam)	3	
Fine leaf litter (<2cm diam)	1	
Bare ground	4	
Grass	6	
Soil cracks	0	
Stones (20-60 cm)	0	
Boulders (61 cm – 2 m)	0	
Large boulders (>2 m)	0	
Rock crevices	0	
Exfoliating rock	0	
^Abundance key: 0 = nil, 1 = Rare, 2 = Rare to occasional, 3 = Occasional, 4 = Occasional to common, 5 = common, 6 = common to abundant, 7 = Abundant		
<b>Other habitat features and notes (e.g. potential threatened species):</b> no threatened fauna recorded within vegetation management area avoid clearing fauna habitat features/potential breeding places within vegetation management area potential habitat for squatter pigeon, powerful owl, koala

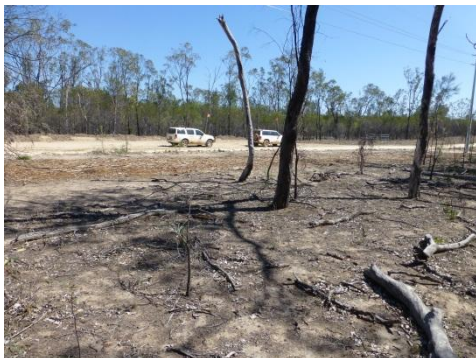
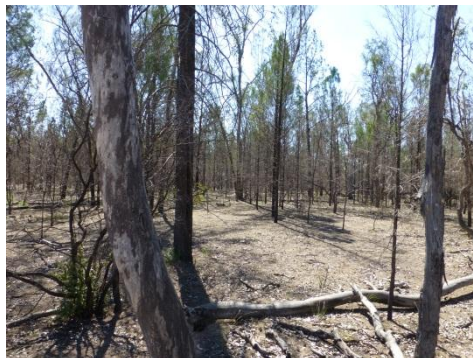
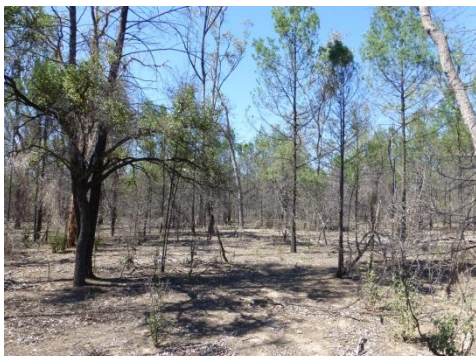
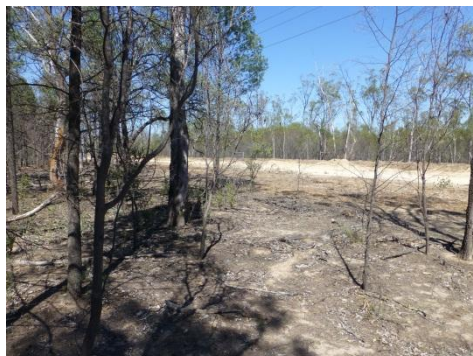
Site habitat assessment		
Site: HA 15	Date: 14/12/2013	Observers: LM
Photo nos: North: 539, East: 540, South: 541, West: 542		
RE type: 11.10.11/11.10.7a	GPS Co-ords: 706815, 7146257	
<b>Habitat description:</b> <i>Eucalyptus populnea</i> woodland with dense shrubby understorey, RoW 28CP		
<b>Trees with hollows (in 100 x 50 (0.5 ha area))</b>	<b>No. of trees containing hollows (tally)</b>	<b>Total number of hollows</b>
Hollow size < 10 cm diameter	1	2
Hollow size > 10 cm diameter	1	3
<b>Hollow bearing logs (in 100 x 50 (0.5 ha area)), hollows &gt;10 cm diameter</b>	<b>No. of logs containing hollows (tally)</b>	<b>Total number of hollows in logs</b>
	0	0
<b>Fallen woody material (in 50 x 10 (0.05 ha area))</b>	<b>Total length of logs &gt;10 cm diameter</b> Total: 62 m	<b>Total number of logs (tally)</b>
		24
<b>Other habitat characteristics (in 100 x 50 (0.5 ha area):</b>		
<b>Characteristic</b>	<b>Abundance (0-7)^</b>	<b>Notes</b>

Decorticating bark	3	
Course leaf litter (>2cm diam)	1	
Fine leaf litter (<2cm diam)	3	
Bare ground	6	
Grass	2	
Soil cracks	0	
Stones (20-60 cm)	0	
Boulders (61 cm – 2 m)	0	
Large boulders (>2 m)	0	
Rock crevices	0	
Exfoliating rock	0	
^Abundance key: 0 = nil, 1 = Rare, 2 = Rare to occasional, 3 = Occasional, 4 = Occasional to common, 5 = common, 6 = common to abundant, 7 = Abundant		
<b>Other habitat features and notes (e.g. potential threatened species):</b> no threatened fauna recorded within vegetation management area avoid clearing fauna habitat features/potential breeding places within vegetation management area potential habitat for brigalow scaly foot, squatter pigeon

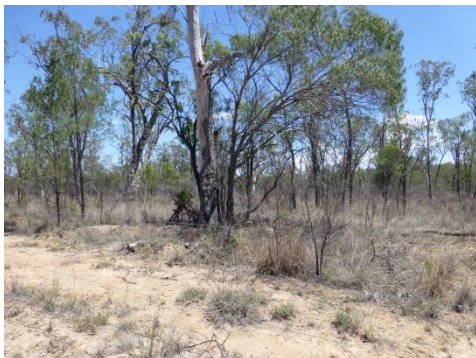
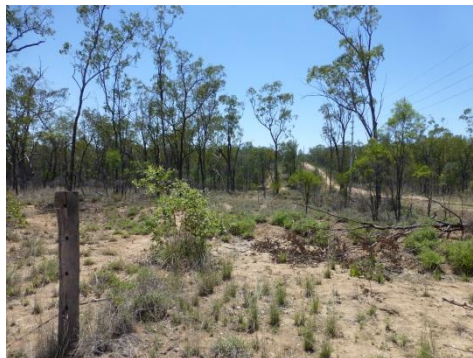
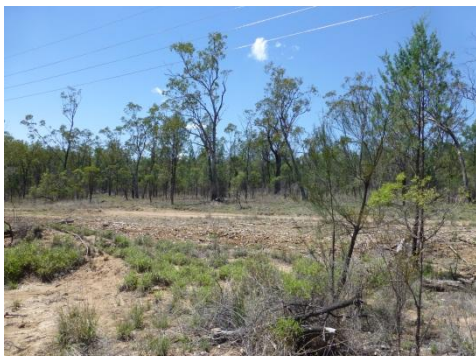
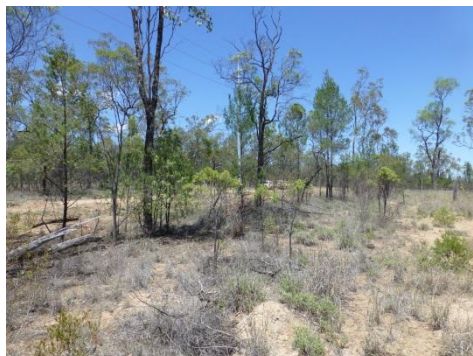
Site habitat assessment		
Site: HA 16	Date: 14/12/2013	Observers: LM
Photo nos: North: 543, East: 544, South: 545, West: 546		
RE type: 11.3.2	GPS Co-ords: 709848, 7147787	
<b>Habitat description:</b> <i>Eucalyptus populnea</i> woodland with a mid-dense shrublayer and grassy groundlayer , RoW 29BP		
<b>Trees with hollows (in 100 x 50 (0.5 ha area))</b>	<b>No. of trees containing hollows (tally)</b>	<b>Total number of hollows</b>
Hollow size < 10 cm diameter	4	8
Hollow size > 10 cm diameter	3	3
<b>Hollow bearing logs (in 100 x 50 (0.5 ha area)), hollows &gt;10 cm diameter</b>	<b>No. of logs containing hollows (tally)</b>	<b>Total number of hollows in logs</b>
	0	0
<b>Fallen woody material (in 50 x 10 (0.05 ha area))</b>	<b>Total length of logs &gt;10 cm diameter</b> Total: 41 m	<b>Total number of logs (tally)</b>
		8
<b>Other habitat characteristics (in 100 x 50 (0.5 ha area):</b>		
<b>Characteristic</b>	<b>Abundance (0-7)^</b>	<b>Notes</b>

Decortivating bark	3	
Course leaf litter (>2cm diam)	3	
Fine leaf litter (<2cm diam)	2	
Bare ground	3	
Grass	6	
Soil cracks	0	
Stones (20-60 cm)	0	
Boulders (61 cm – 2 m)	0	
Large boulders (>2 m)	0	
Rock crevices	0	
Exfoliating rock	0	
^Abundance key: 0 = nil, 1 = Rare, 2 = Rare to occasional, 3 = Occasional, 4 = Occasional to common, 5 = common, 6 = common to abundant, 7 = Abundant		
<b>Other habitat features and notes (e.g. potential threatened species):</b> no threatened fauna recorded within vegetation management area avoid clearing fauna habitat features/potential breeding places and Type A restricted plants within vegetation management area potential habitat for squatter pigeon, koala
