**Santos GLNG Project**  
**Lot 55 FTY1153**  
**Vegetation Management Zones Ecological Assessment**  
**Report**

February 2014

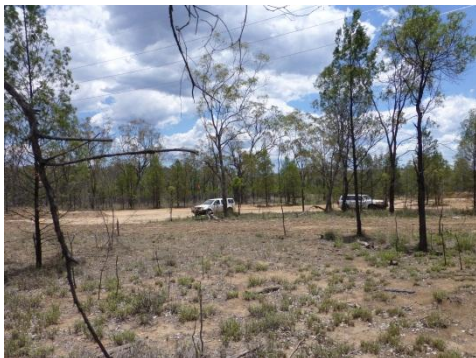
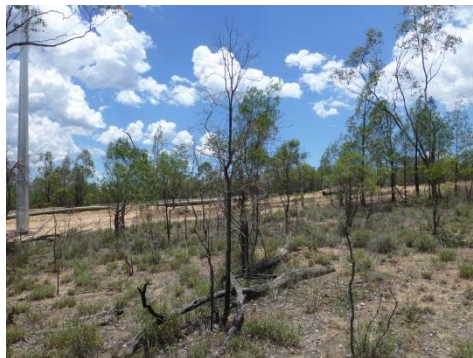
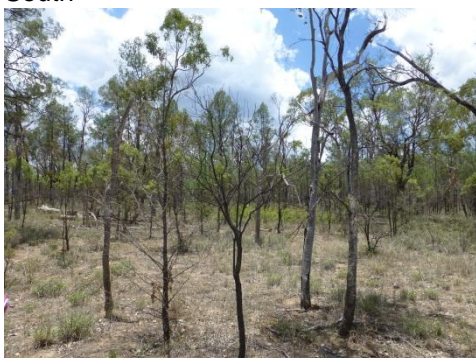
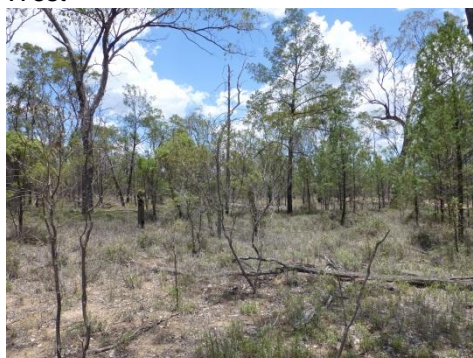
Site habitat assessment		
Site: HA 17	Date: 14/12/2013	Observers: LM
Photo nos: North: 547, East: 548, South: 549, West: 550		
RE type: 11.3.2	GPS Co-ords: 711070, 7148133	
<b>Habitat description:</b> <i>Eucalyptus populnea</i> woodland with a dense shrubby understorey , RoW 36B		
<b>Trees with hollows (in 100 x 50 (0.5 ha area))</b>	<b>No. of trees containing hollows (tally)</b>	<b>Total number of hollows</b>
Hollow size < 10 cm diameter	4	6
Hollow size > 10 cm diameter	1	3
<b>Hollow bearing logs (in 100 x 50 (0.5 ha area)), hollows &gt;10 cm diameter</b>	<b>No. of logs containing hollows (tally)</b>	<b>Total number of hollows in logs</b>
	2	4
<b>Fallen woody material (in 50 x 10 (0.05 ha area))</b>	<b>Total length of logs &gt;10 cm diameter</b> Total: 57 m	<b>Total number of logs (tally)</b>
		8
<b>Other habitat characteristics (in 100 x 50 (0.5 ha area):</b>		
<b>Characteristic</b>	<b>Abundance (0-7)^</b>	<b>Notes</b>

Decorticating bark	3	
Course leaf litter (>2cm diam)	3	
Fine leaf litter (<2cm diam)	3	
Bare ground	4	
Grass	6	
Soil cracks	0	
Stones (20-60 cm)	0	
Boulders (61 cm – 2 m)	0	
Large boulders (>2 m)	0	
Rock crevices	0	
Exfoliating rock	0	
^Abundance key: 0 = nil, 1 = Rare, 2 = Rare to occasional, 3 = Occasional, 4 = Occasional to common, 5 = common, 6 = common to abundant, 7 = Abundant		
<b>Other habitat features and notes (e.g. potential threatened species):</b> no threatened fauna recorded within vegetation management area avoid clearing fauna habitat features/potential breeding places within vegetation management area potential habitat for brigalow scaly foot, squatter pigeon, golden tail gecko

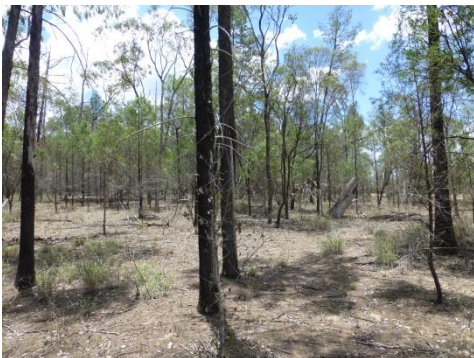
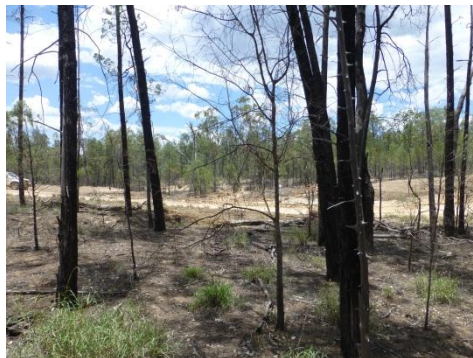
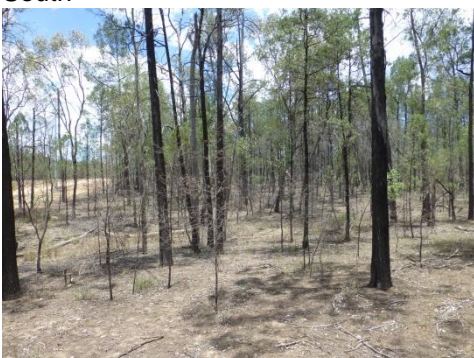
Site habitat assessment		
Site: HA 18	Date: 14/12/2013	Observers: LM
Photo nos: North: 556, East: 557, South: 558, West: 559		
RE type: 11.10.9	GPS Co-ords: 711405, 7147698	
<b>Habitat description:</b> <i>Callitris glaucophylla</i> dominated open forest with dense shrubs and a grassy understorey. Emergent eucalypts also present , RoW 36B		
<b>Trees with hollows (in 100 x 50 (0.5 ha area))</b>	<b>No. of trees containing hollows (tally)</b>	<b>Total number of hollows</b>
Hollow size < 10 cm diameter	2	3
Hollow size > 10 cm diameter	7	9
<b>Hollow bearing logs (in 100 x 50 (0.5 ha area)), hollows &gt;10 cm diameter</b>	<b>No. of logs containing hollows (tally)</b>	<b>Total number of hollows in logs</b>
	4	5
<b>Fallen woody material (in 50 x 10 (0.05 ha area))</b>	<b>Total length of logs &gt;10 cm diameter</b> Total: 69 m	<b>Total number of logs (tally)</b>
		8
<b>Other habitat characteristics (in 100 x 50 (0.5 ha area):</b>

<b>Characteristic</b>	<b>Abundance (0-7)^</b>	<b>Notes</b>
Decorticating bark	2	
Course leaf litter (>2cm diam)	3	
Fine leaf litter (<2cm diam)	4	
Bare ground	5	
Grass	4	
Soil cracks	0	
Stones (20-60 cm)	0	
Boulders (61 cm – 2 m)	0	
Large boulders (>2 m)	0	
Rock crevices	0	
Exfoliating rock	0	
^Abundance key: 0 = nil, 1 = Rare, 2 = Rare to occasional, 3 = Occasional, 4 = Occasional to common, 5 = common, 6 = common to abundant, 7 = Abundant		
<b>Other habitat features and notes (e.g. potential threatened species):</b> no threatened fauna recorded within vegetation management area avoid clearing watercourse area and fauna habitat features/potential breeding places within vegetation management area potential habitat for squatter pigeon, golden tail gecko

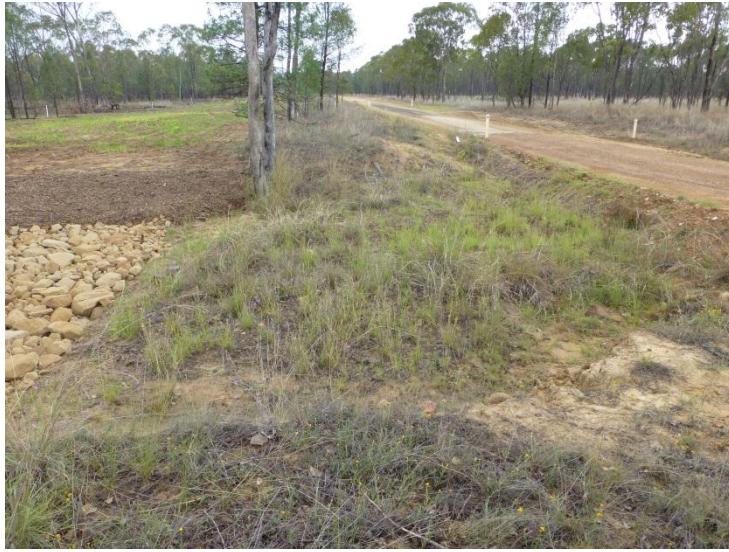
**Photo A – Looking across the waterway at the proposed site works**  
Vegetation Management Area

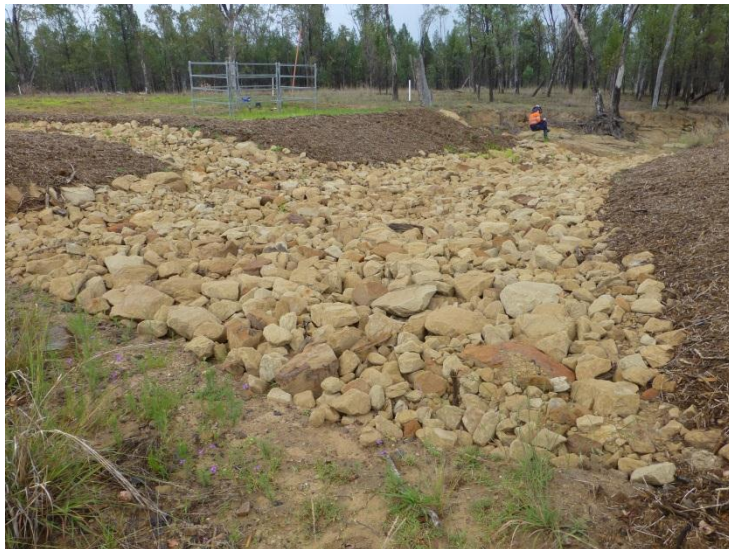
Powerline RoW 45 easement

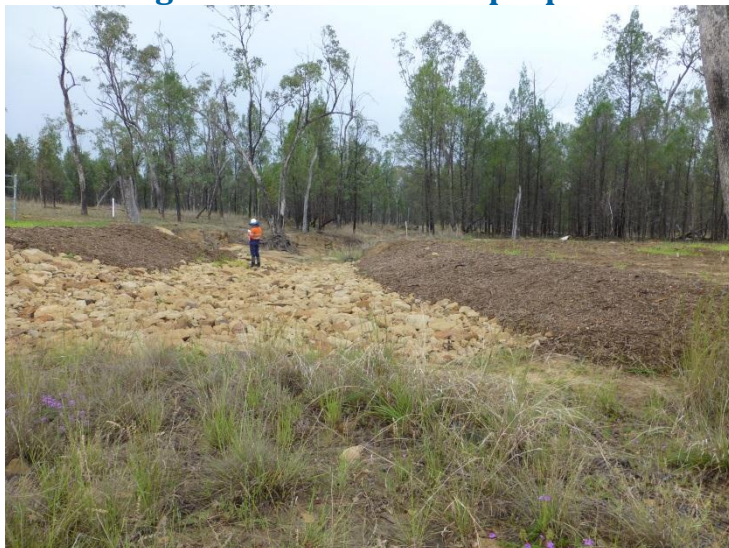
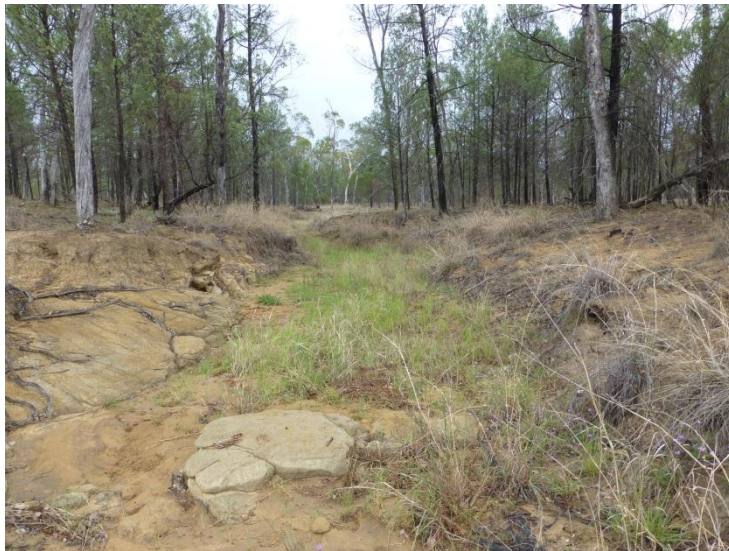
**Photo B – Looking downstream of the proposed site of works**

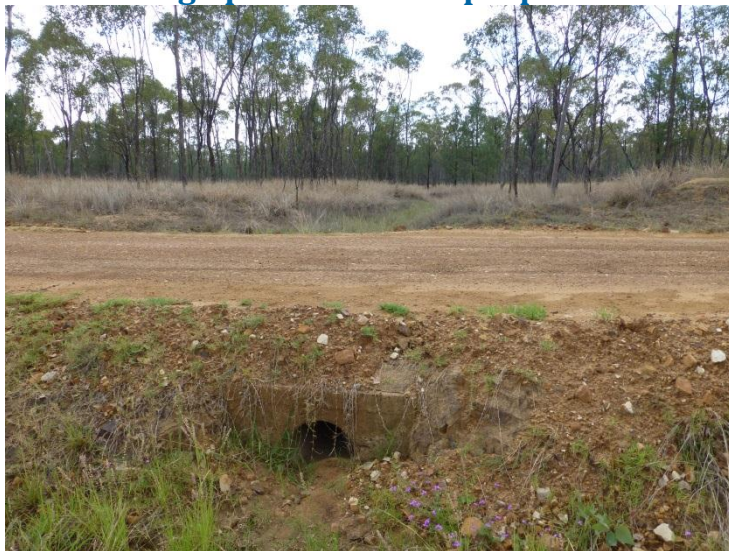
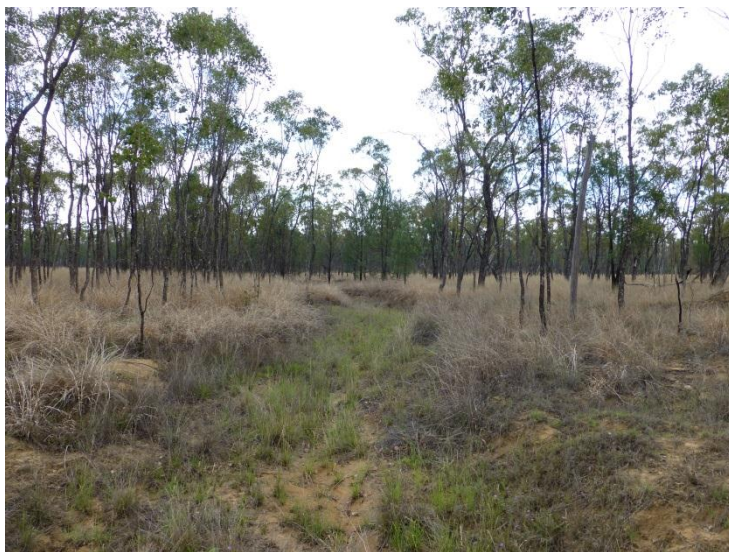
**Photo C - Looking upstream of the proposed site of works**

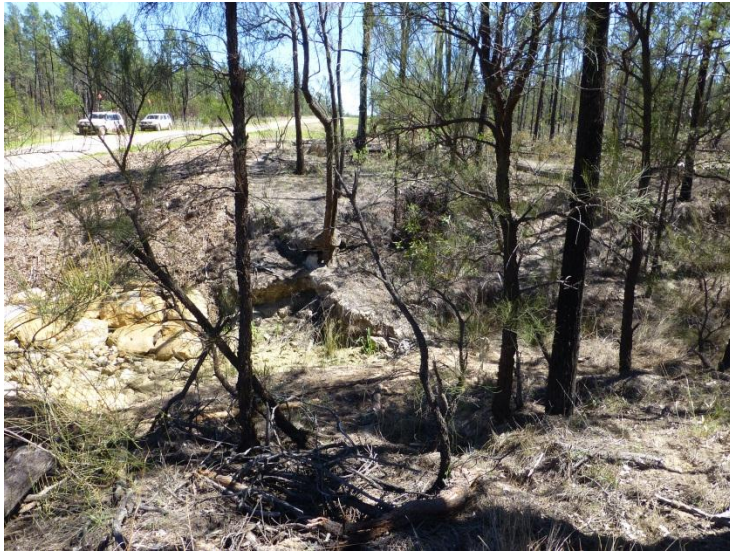
**Photo A – Looking across the waterway at the proposed site works**  
Vegetation Management Area

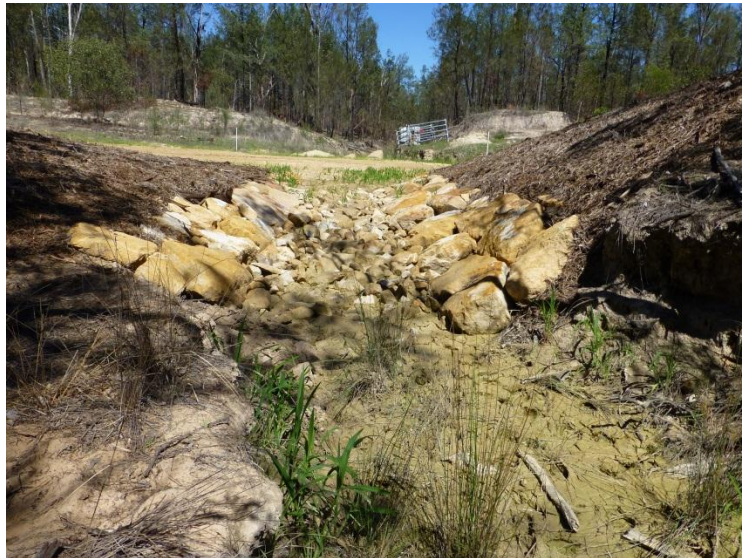
**Photo B – Looking downstream of the proposed site of works**

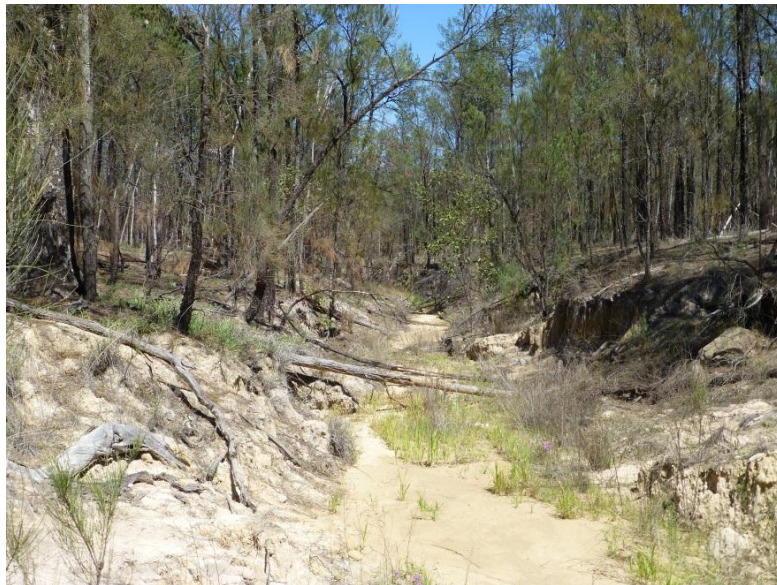
**Photo C - Looking upstream of the proposed site of works**

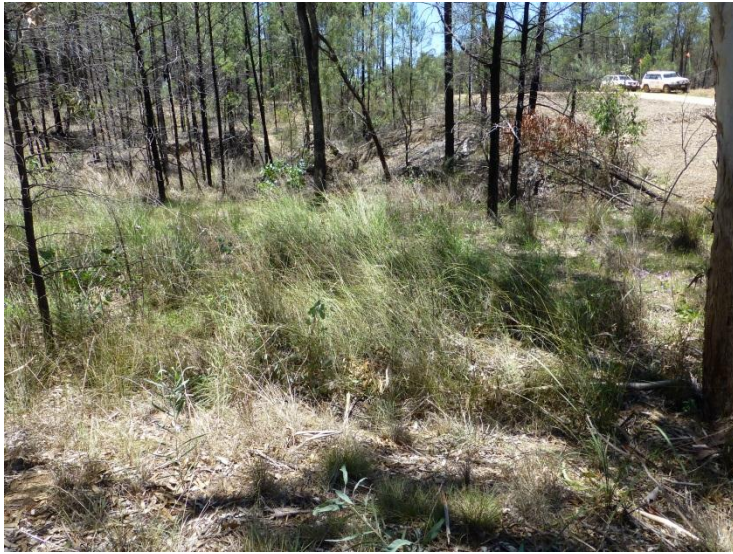
**Photo A - Looking across the waterway at the proposed site works**  
Vegetation Management Area

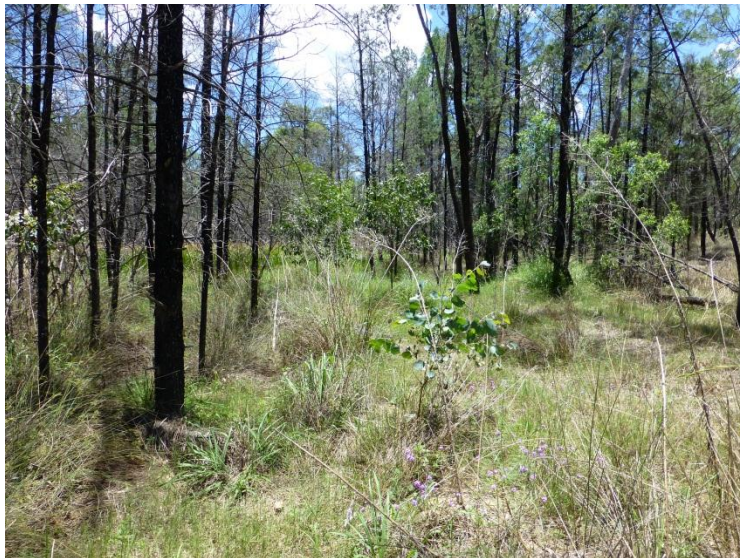
**Photo B - Looking downstream of the proposed site of works**

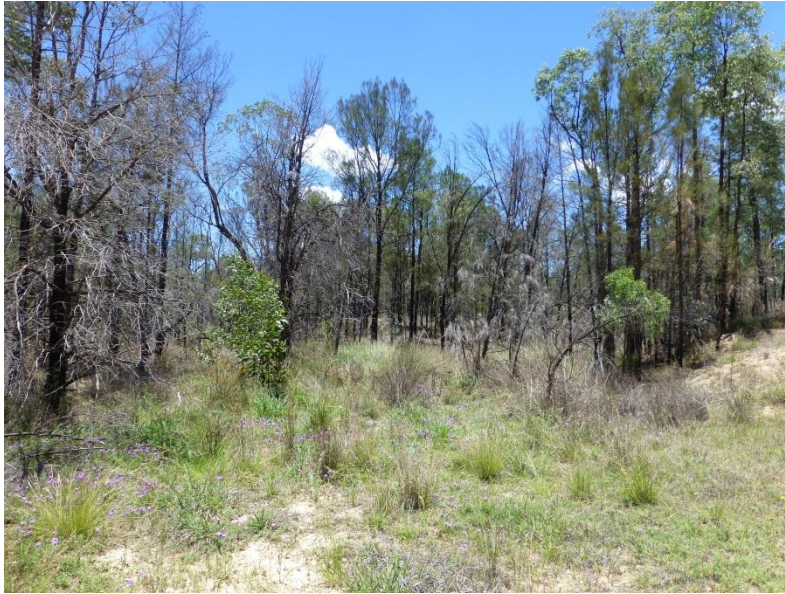
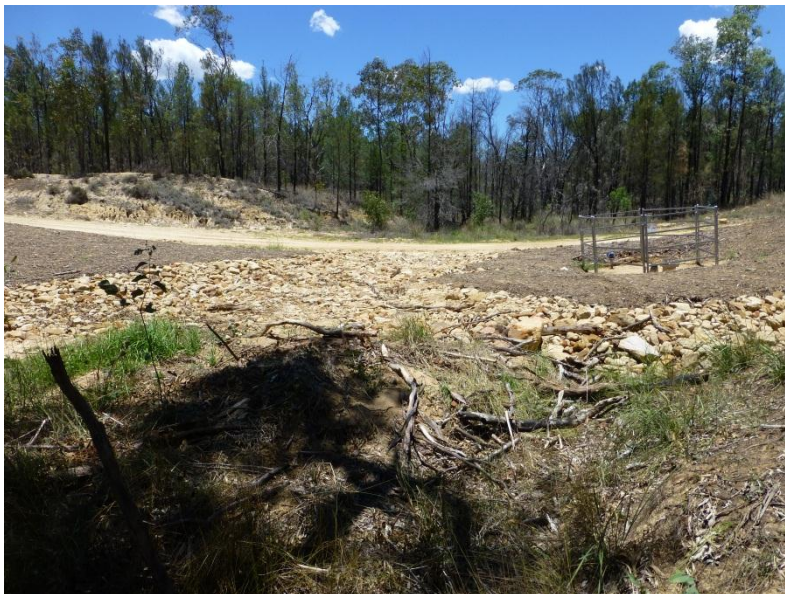
**Photo C – Looking upstream of the proposed site of works**

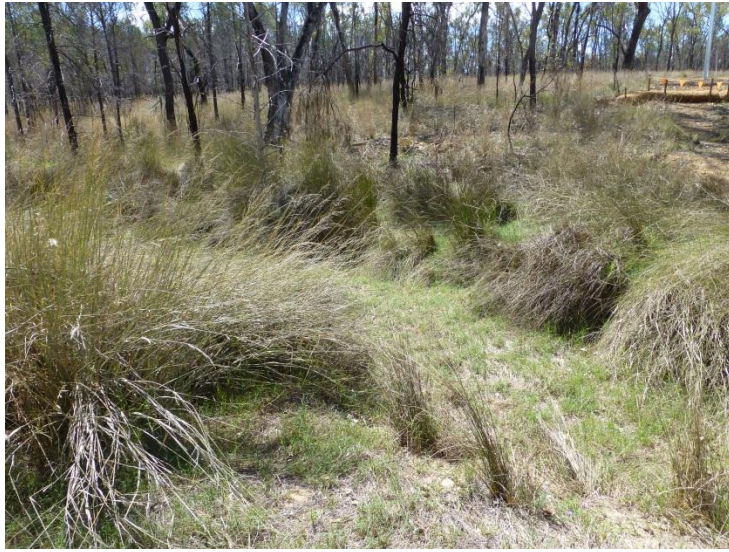
**Photo A – Looking across the waterway at the proposed site works**  
Vegetation Management Area

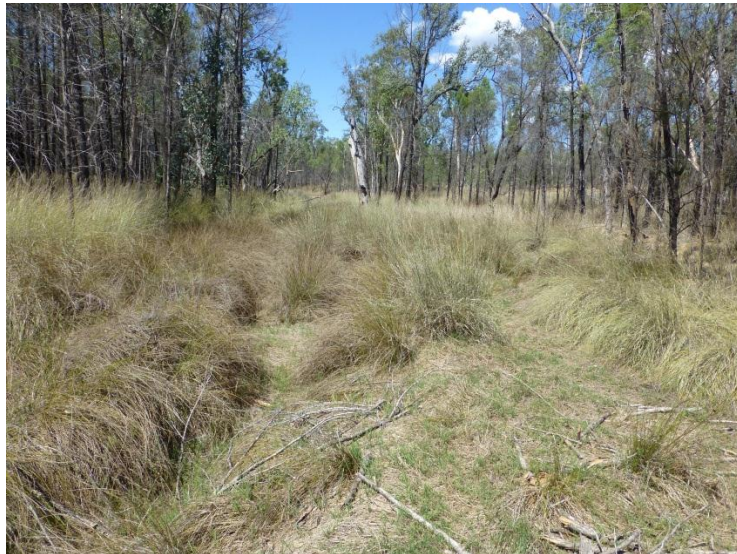
**Photo B – Looking downstream of the proposed site of works**

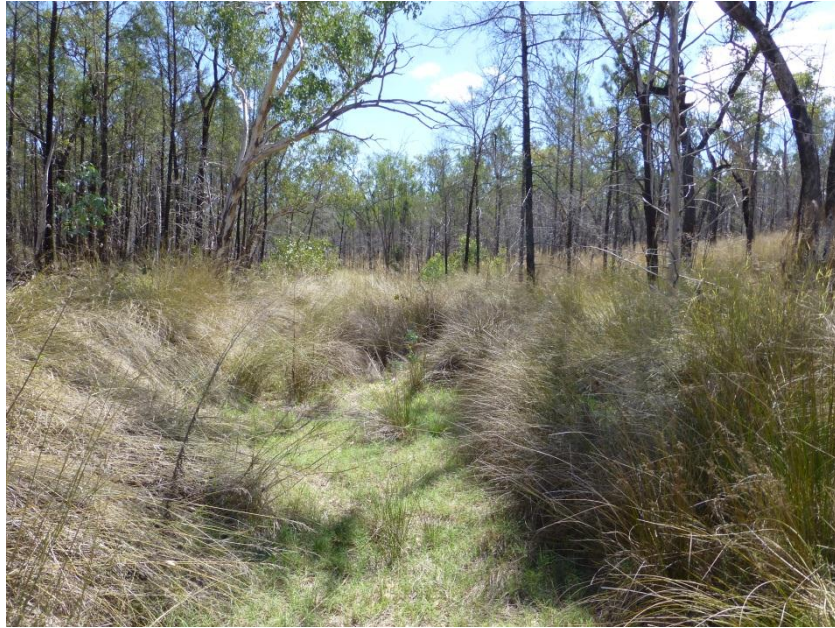
**Photo C – Looking upstream of the proposed site of works**

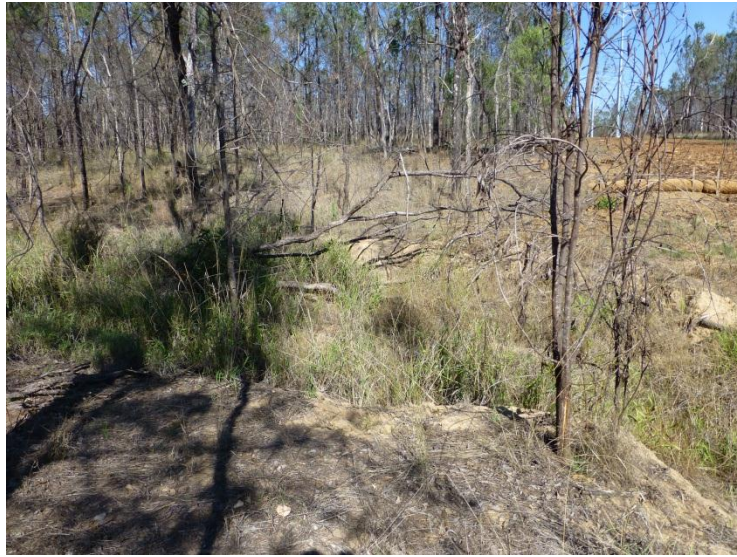
**Photo A - Looking across the waterway at the proposed site works**  
Vegetation Management Area

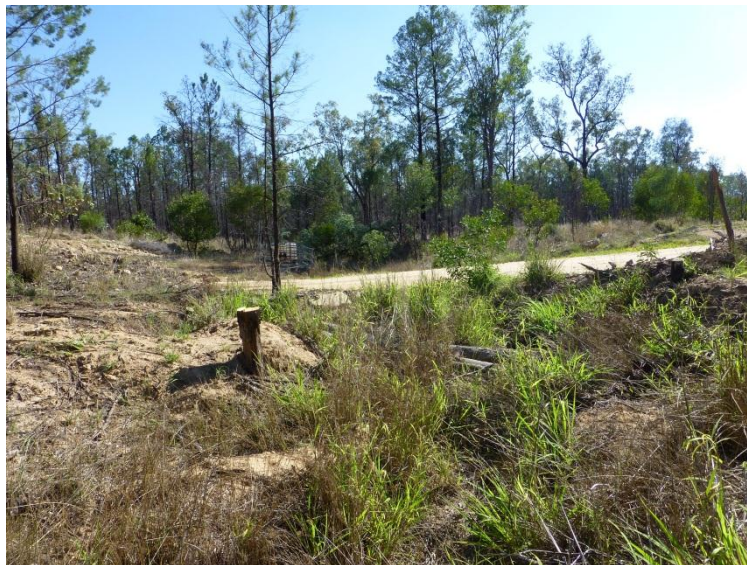
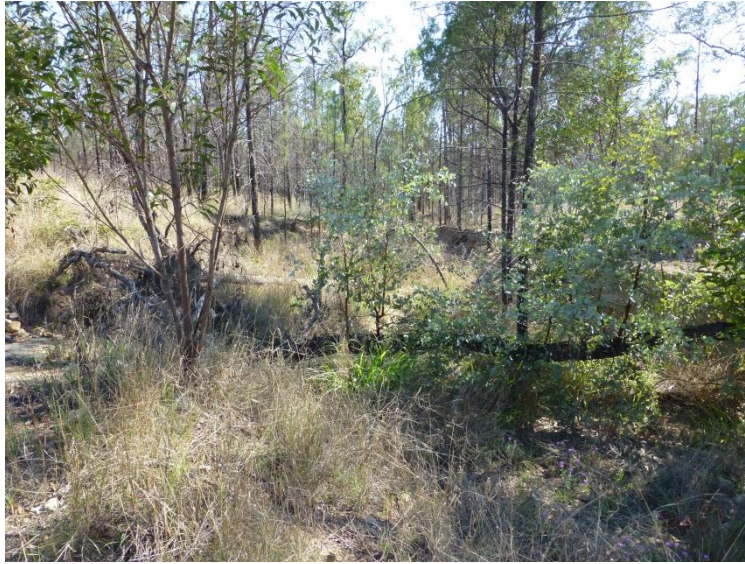
**Photo B - Looking downstream of the proposed site of works**

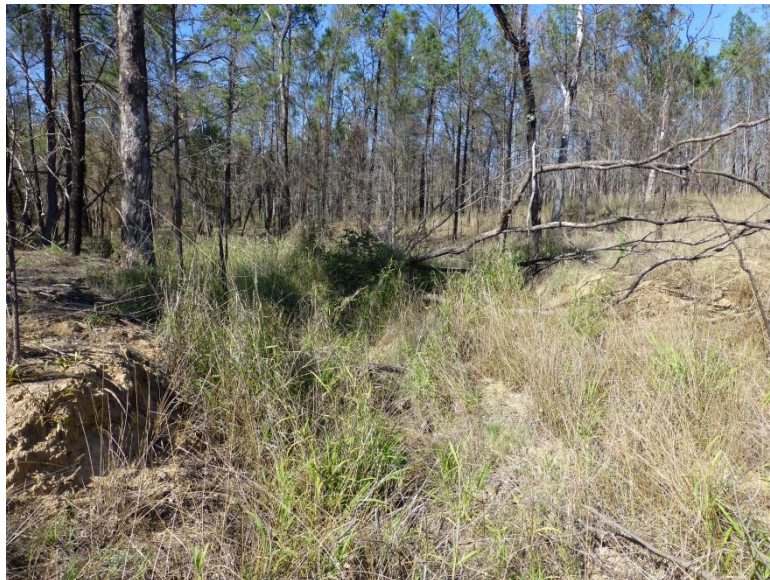
**Photo C - Looking upstream of the proposed site of works**

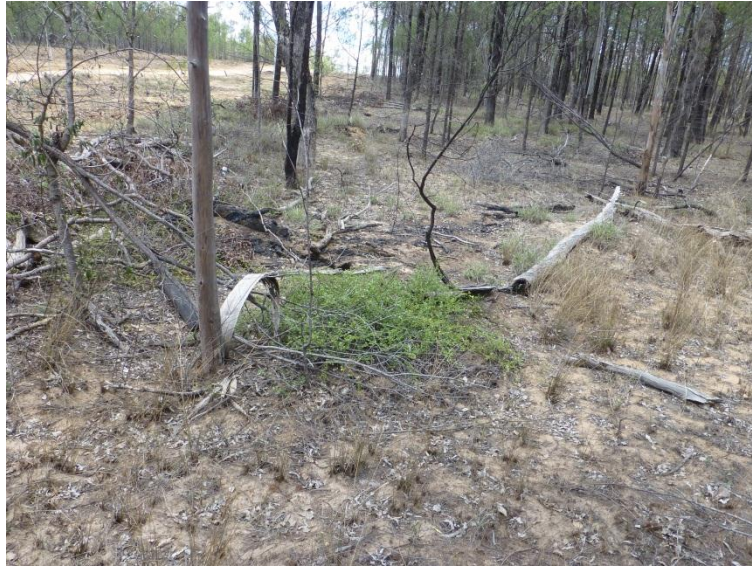
### Photo A - Looking across the waterway at the proposed site works Vegetation Management Area

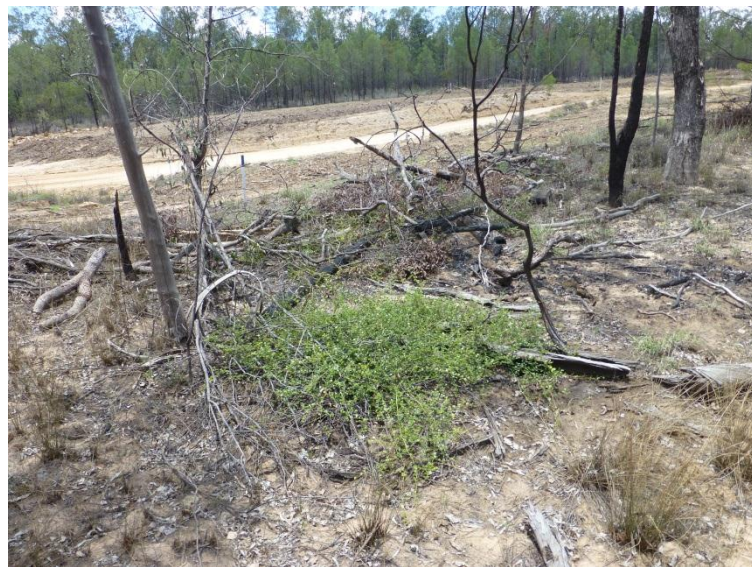
Woody debris is channel

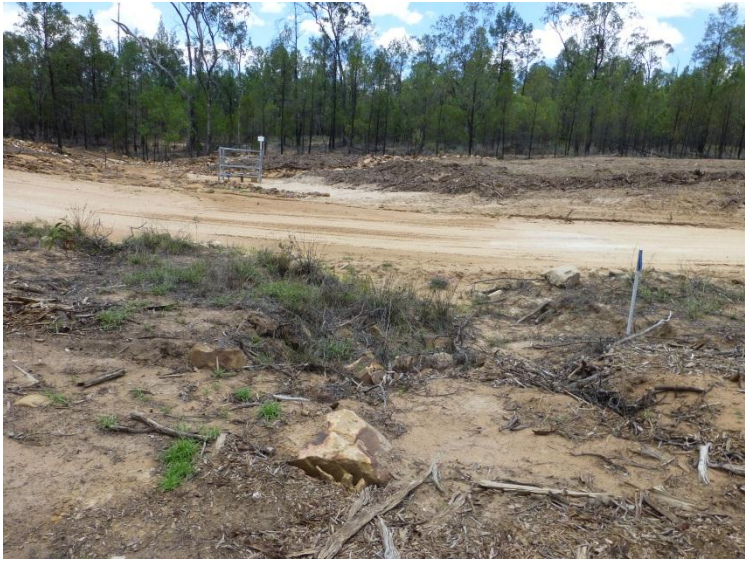
**Photo B – Looking downstream of the proposed site of works**

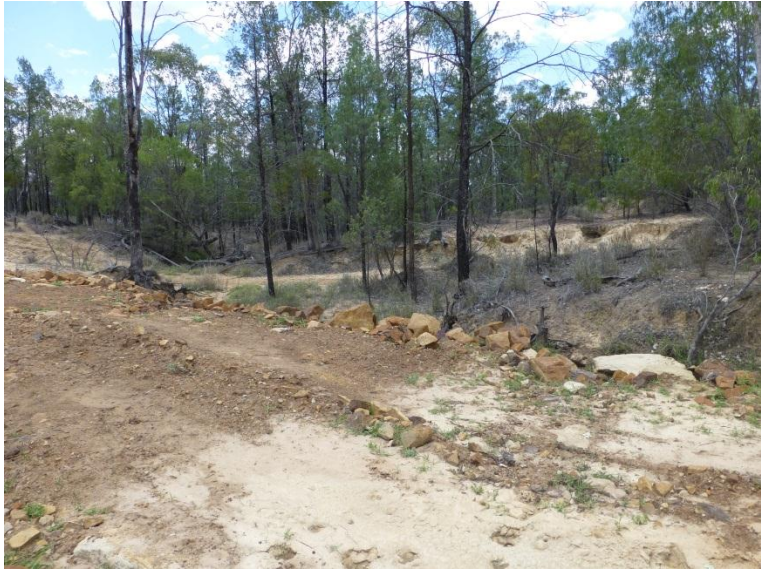
**Photo C – Looking upstream of the proposed site of works**
